**Appendix A – Hydrogeological Technical Study**

**Proposed Black Point Quarry Project  
Guysborough County, Nova Scotia**

**Hydrogeological Technical Report**

**February 2015  
SLR Project No.: 210.05913.00000**

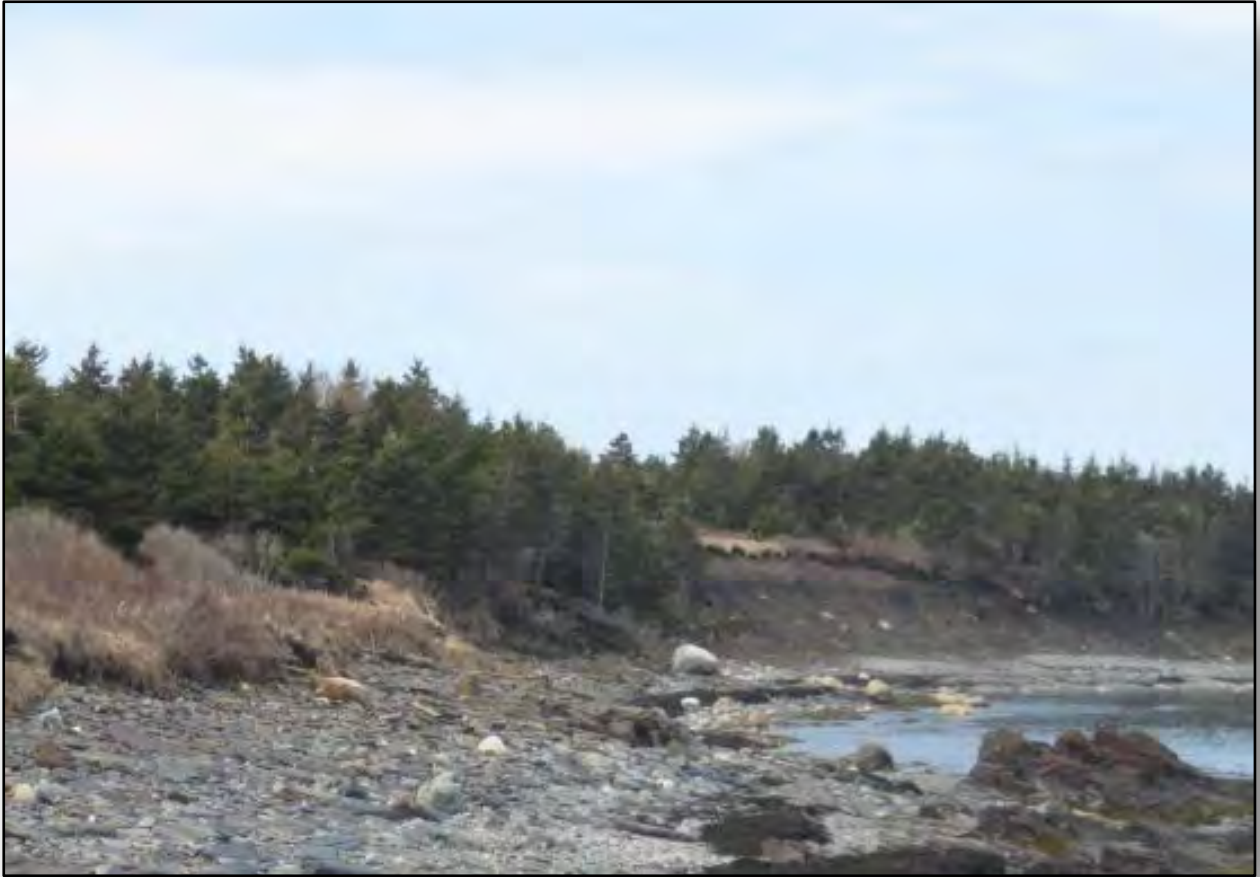
**Figure 1**  
**Photo - View from the east side of Gaulman Point looking at glacial tills.**

Glacial tills in the background of Figure 1 host dug wells along Half Island Cove Road. An outcrop of Halifax Formation bedrock and marine beach deposits are shown in the foreground.

Observations made on site indicate these tills are essentially absent on the top of the granite hill, but thicken on the slopes of the hill at lower elevations. The tills are well exposed along the coastline at Half Island Cove (Figure 1) and Fox Island Main. Dug wells, which are used more often than drilled wells in this area to provide potable water, are installed in these tills. Well records obtained from NSE indicate that surficial deposits are generally comprised of various mixtures of clay, sand, gravel and boulders and vary in thickness between approximately 1 m and 19 m, which is consistent with the geologic mapping.

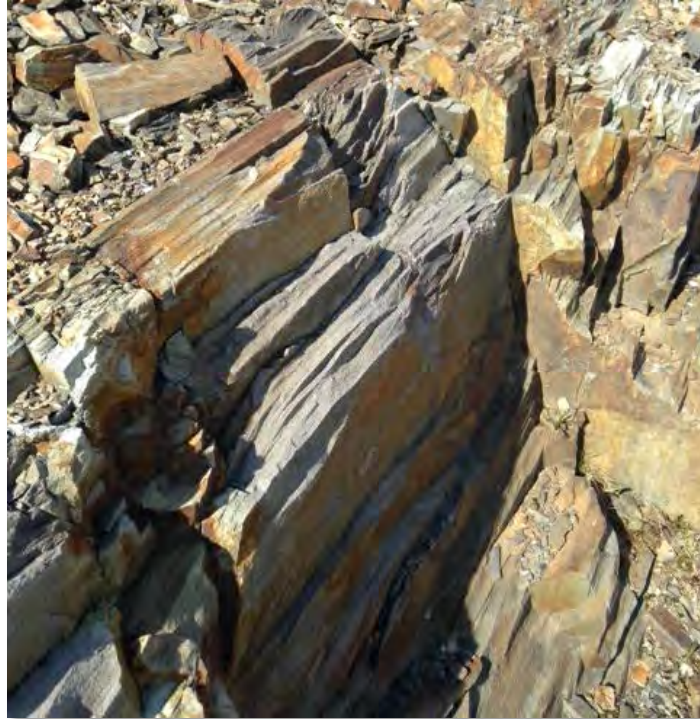
**Figure 2**

**Photo – Outcrop of Goldenville Formation showing vertical bedding and jointing.**

The geology surrounding the Project site consists of Cambro-Ordovician age metamorphosed sedimentary rocks (metasediments) of the Goldenville and Halifax Formations. The Goldenville Formation is the oldest and is generally found to the south and west of the Project site, with some outcrop on the tip of the Fogherty Head / Black Point headland. The Goldenville Formation comprises a thickly bedded metawacke with minor metapelite (<5%). Photographs showing the Goldenville Formation in situ are presented in Figure 2.

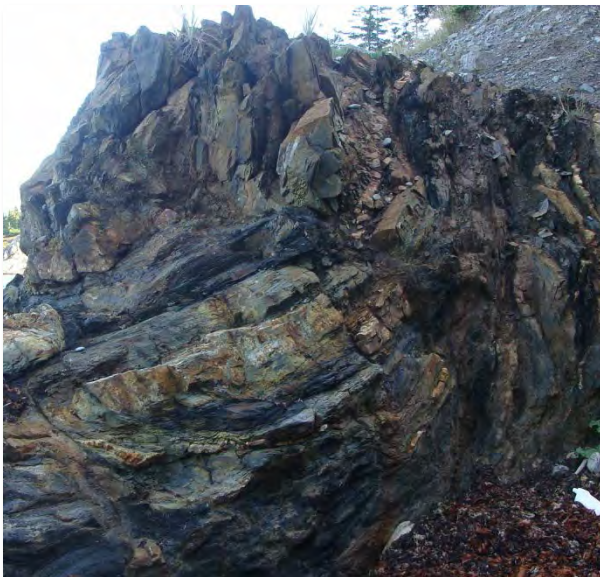
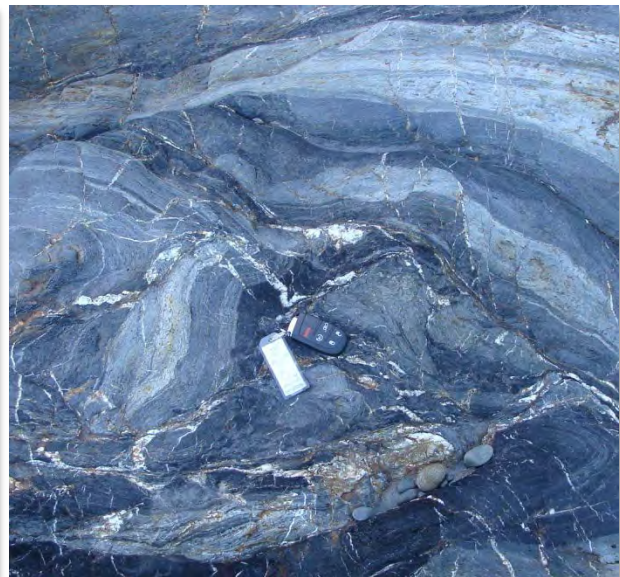
Immediately to the south of the faulted boundary with the Goldenville Formation on the Fogherty Head / Black Point headland lies the Halifax formation, comprising a porphyroblastic, sulphide-bearing, graphite schist interbedded with thin layers of metawacke (Hill 1991). Figure 3 illustrates the highly deformed and sheared Halifax Formation in outcrop.

**Figure 3**  
**Photo - Outcrop of Halifax Formation (left) and shearing detail in closeup (right).**

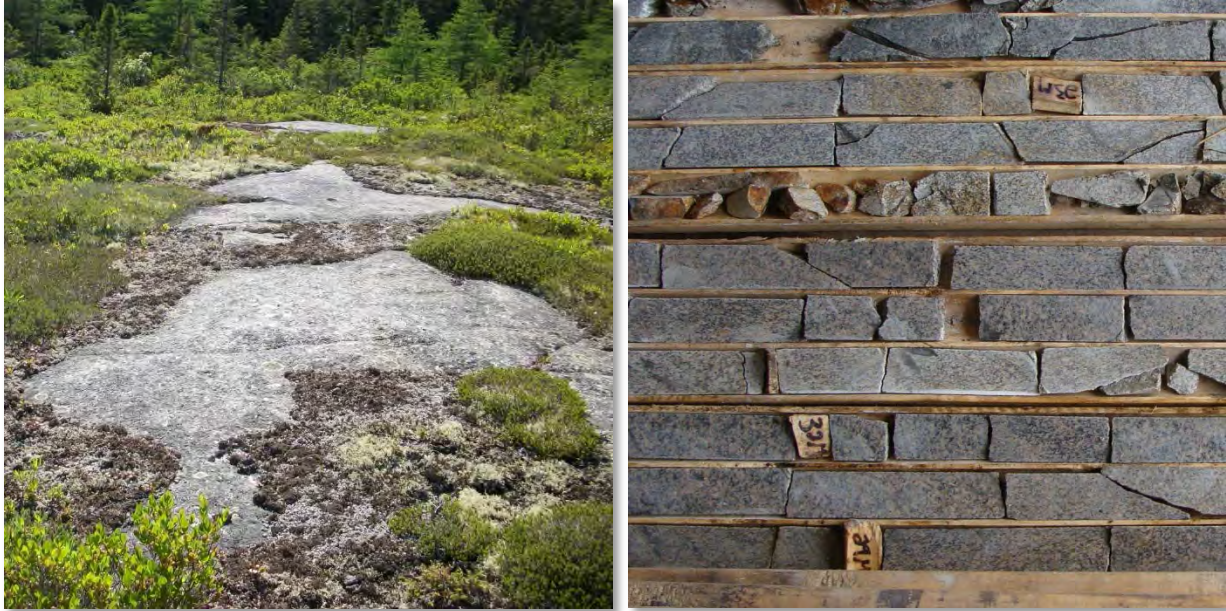
**Figure 4**  
**Photo - Outcrop of granite (left) and core detail in closeup (right).**

The granite does not exhibit a structural fabric, i.e. it is massive as illustrated in the outcrop and core photographs in Figure 4, and is not sheared or deformed. The core logs indicate that the most frequent fracturing and jointing occurs in the upper 40 m as demonstrated by the fracture frequency plot in Attachment B. Two fault zones were noted in the core logs for BP-8 and BP-9 at 93 to 94 m bgs and 20 m to 25 m bgs respectively, and are shown on the fracture plots by fracture frequencies of >20 fractures per metre. Detailed topographic and LiDAR data of the site indicate a bifurcating lineament running from the northwest corner of Murphy's Lake to the minor watercourse to the northeast of Fogherty Lake. This northwest-southeast trend is consistent with known faulting in the area and may indicate the surface expression of a fault zone within the granite. Core holes BP-8 and BP-9 are located close to this lineament and intersect broken zones of rock which may be related to a fault or faults. This is of interest as these zones may provide preferential pathways for groundwater movement into the quarry in future.

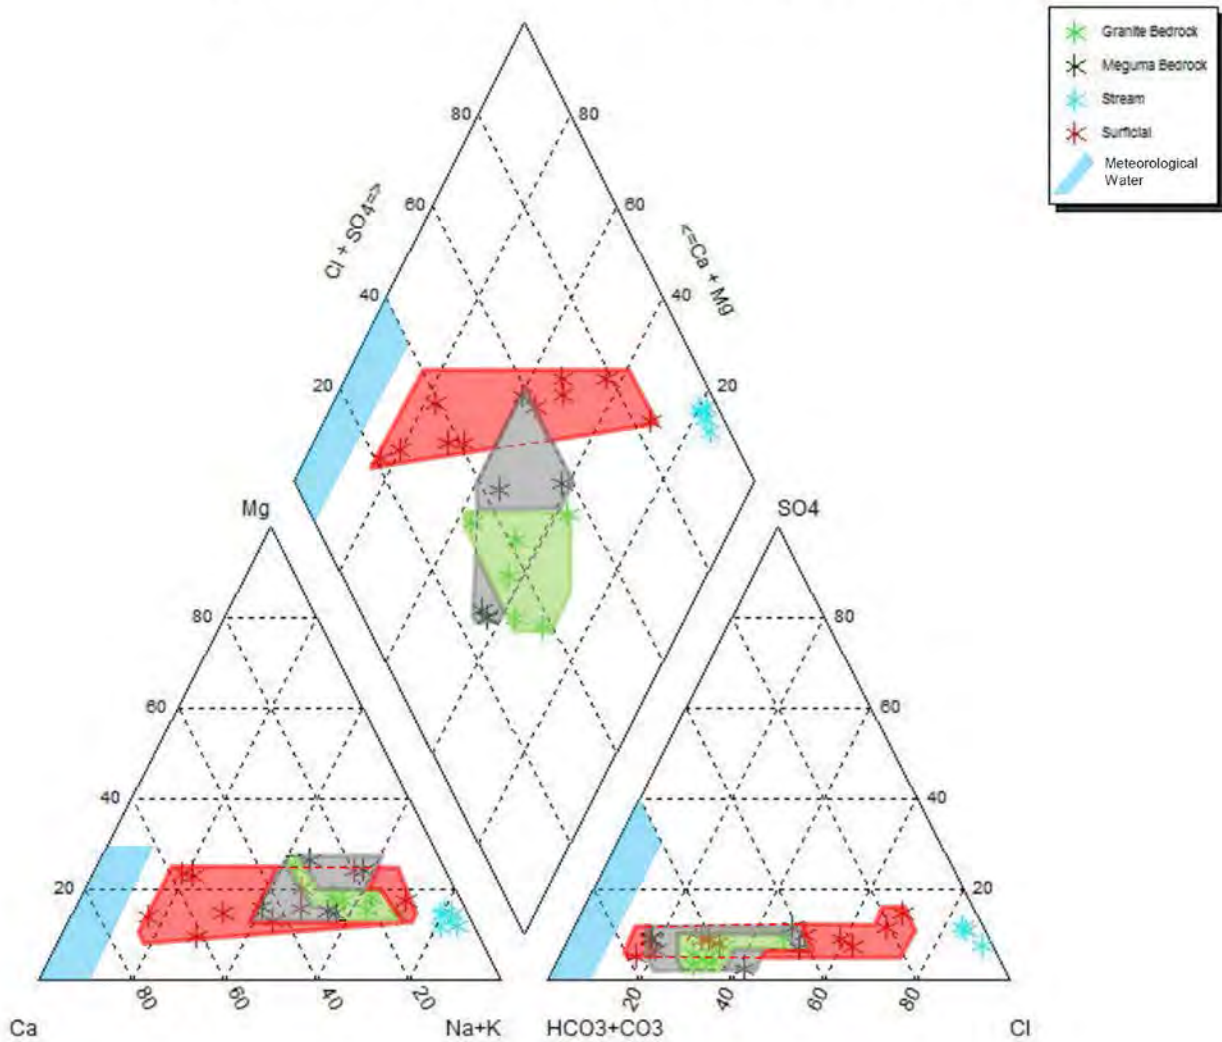
**Figure 5**  
**Piper Plot of Groundwater and Surface Water Quality Collected to Date**

The Piper plot in Figure 5 indicates that the majority of granite samples lie in a zone between Ca-HCO<sub>3</sub>, Na-Cl, and Na-HCO<sub>3</sub> waters, which indicates a mixture of influences from shallow fresh water, marine water and deeper waters influenced by ion exchange. This would be consistent with the mixture of fresher waters from the upper fractured zone within the granite and water from deeper within the granite core holes.

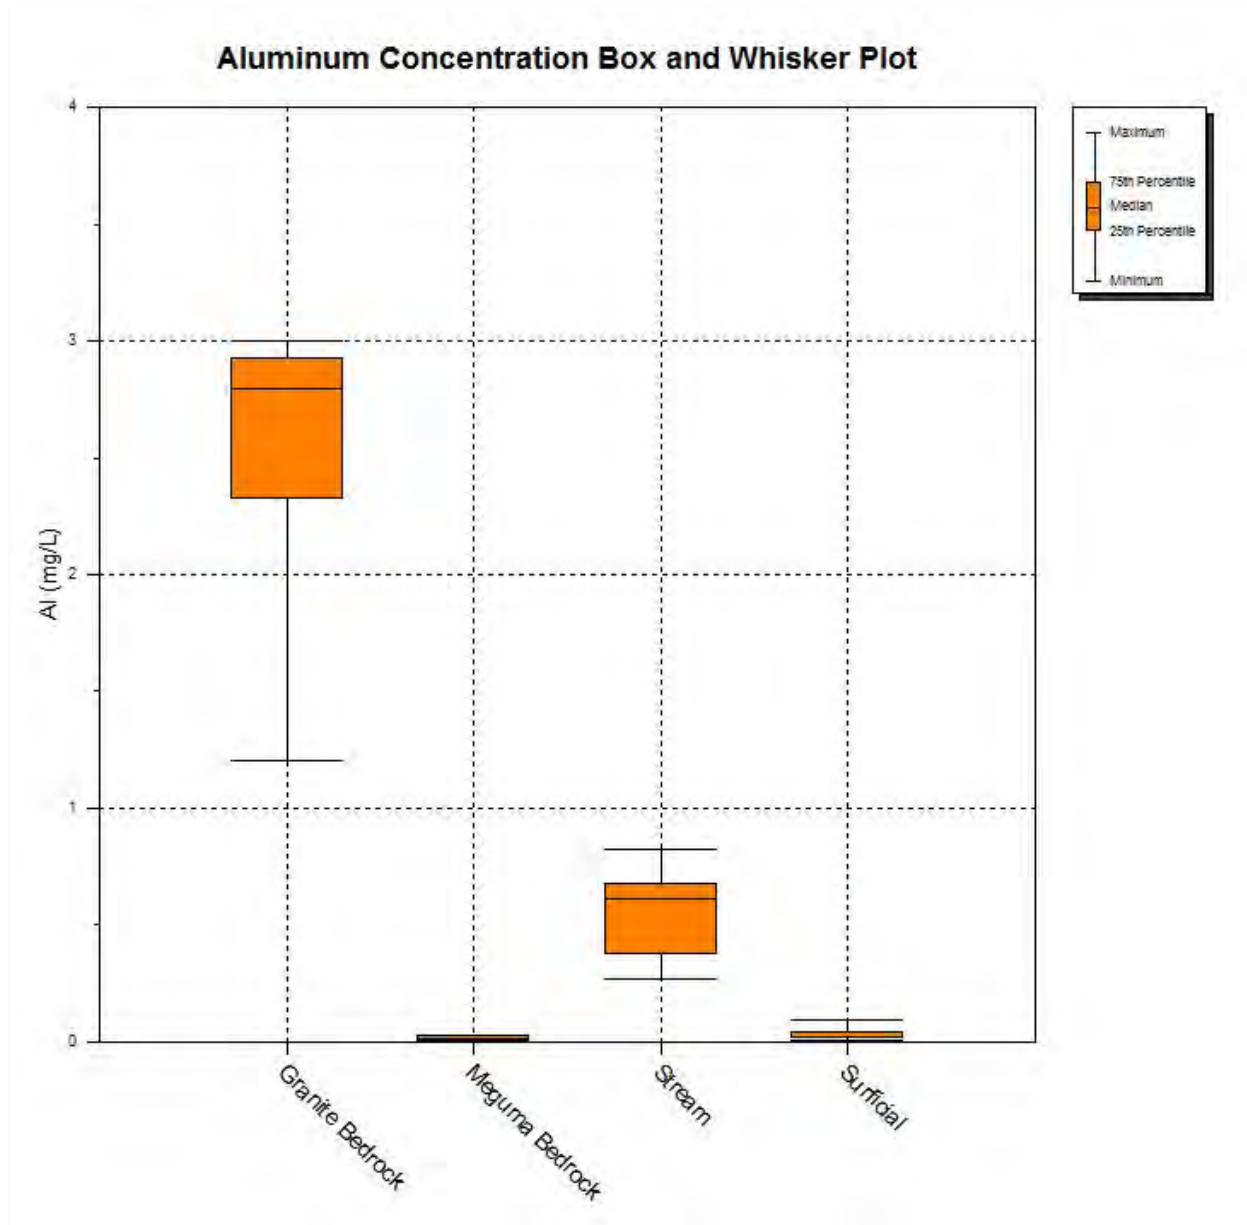
**Figure 6**  
**Box and Whisker Plot of Aluminium in Groundwater and Surface Water**

Table 3 and Figures 6 and 7 indicate that groundwater in the granite has generally high concentrations of metals, with exceedences of aesthetic objectives for aluminium, colour, iron and manganese in the majority of samples, and exceedences of the maximum allowable concentrations within several samples for lead, arsenic and uranium. pH values were low in three of the eight samples, indicating slightly acidic conditions within the granite. We underline that the groundwater samples from within the granite have been assessed against the CDWQ

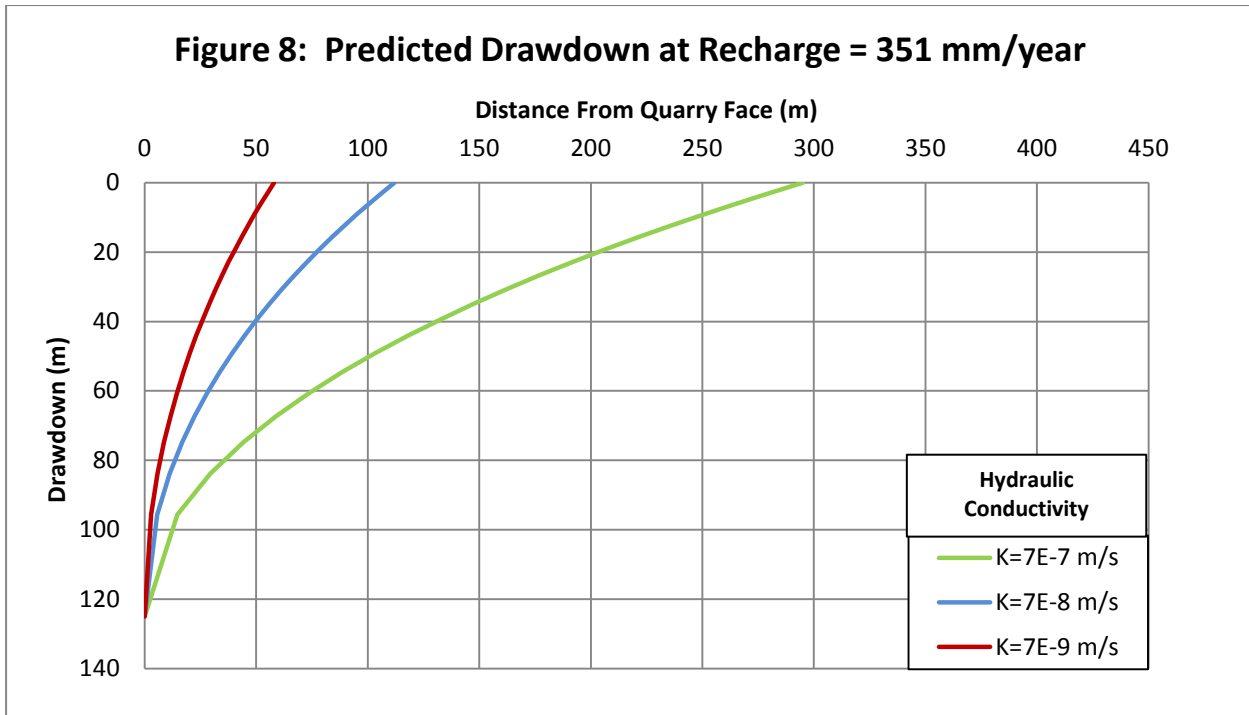
Figure 8 shows that the radius of drawdown reaches a distance from the quarry face of 300 m for the most permeable case of  $K = 7 \times 10^{-7}$  m/s. Where the rock is less permeable this reduces to 115 m and then to 60 m where  $K = 7 \times 10^{-9}$  m/s. This is intuitively correct as the rock is less capable of drainage at these lower values and thus affects less of an area of recharge.

The system is also sensitive to the amount of recharge. In the above example, a recharge rate of 351 mm/yr was selected as that is the average for the site. However, examination of Drawing 12 shows that around the edges of the quarry the recharge rate is locally around 200 mm/yr. Figure 9 has been prepared to show the effect of this lower recharge rate on the drawdown for the range of hydraulic conductivities considered. Since the bedrock can convey a certain amount of water, the extent of the area of drawdown can be greater if there is less recharge to convey. That is, the drawdown of the water table extends further from the quarry in the lower recharge scenario. The radius of drawdown reaches a distance from the quarry face of just about 400 m for the permeable case of  $K = 7 \times 10^{-7}$  m/s. Where the rock is less permeable this reduces to 160 m and then to 90 m where  $K = 7 \times 10^{-9}$  m/s. This recharge rate is adopted as the most conservative “base case”, as it reflects the lower recharge amounts at the top of the quarry walls.

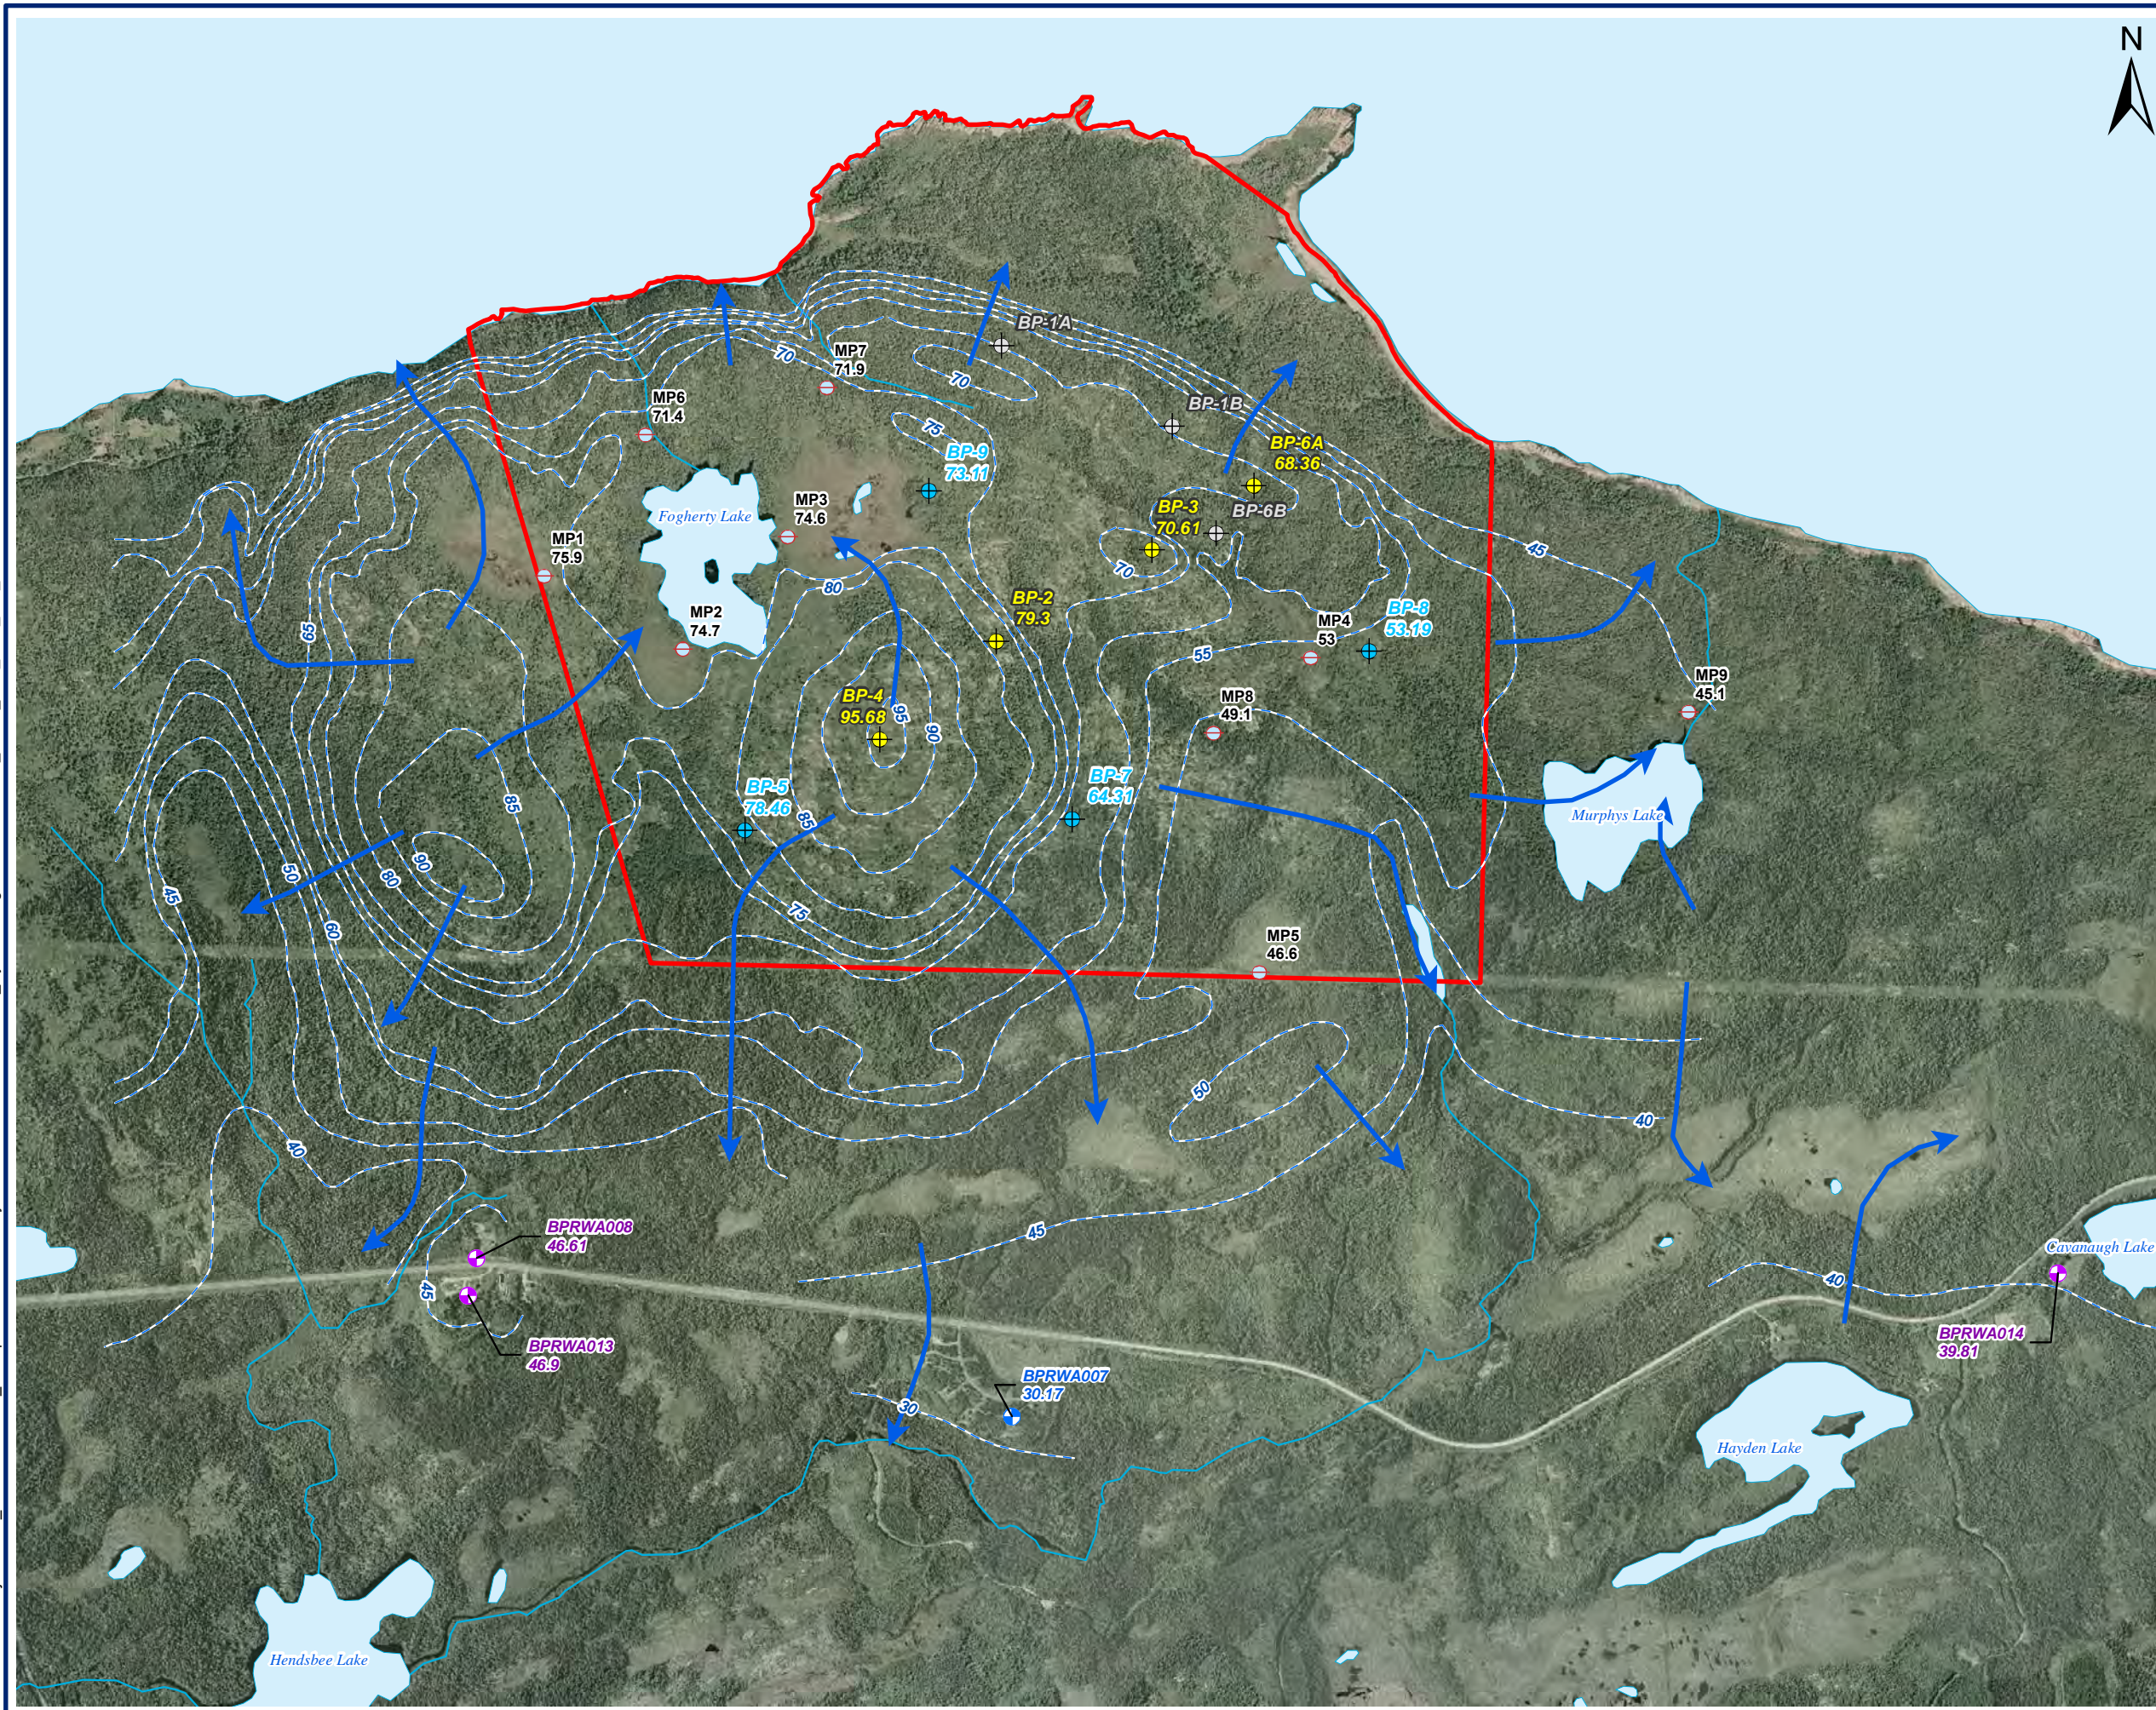
- LEGEND**
- Property Boundary
  - Direction of Groundwater Flow
  - Groundwater Contours (mASL)
  - Waterbody
  - Watercourse
  - ⊕ Drive Point Piezometer
  - ⊕ Drilled Residential Wells
  - ⊕ Dug Residential Wells
  - ⊕ Borehole (Unable to Locate)
  - ⊕ Borehole - Sampled with Water Level Logger
  - ⊕ Borehole Location

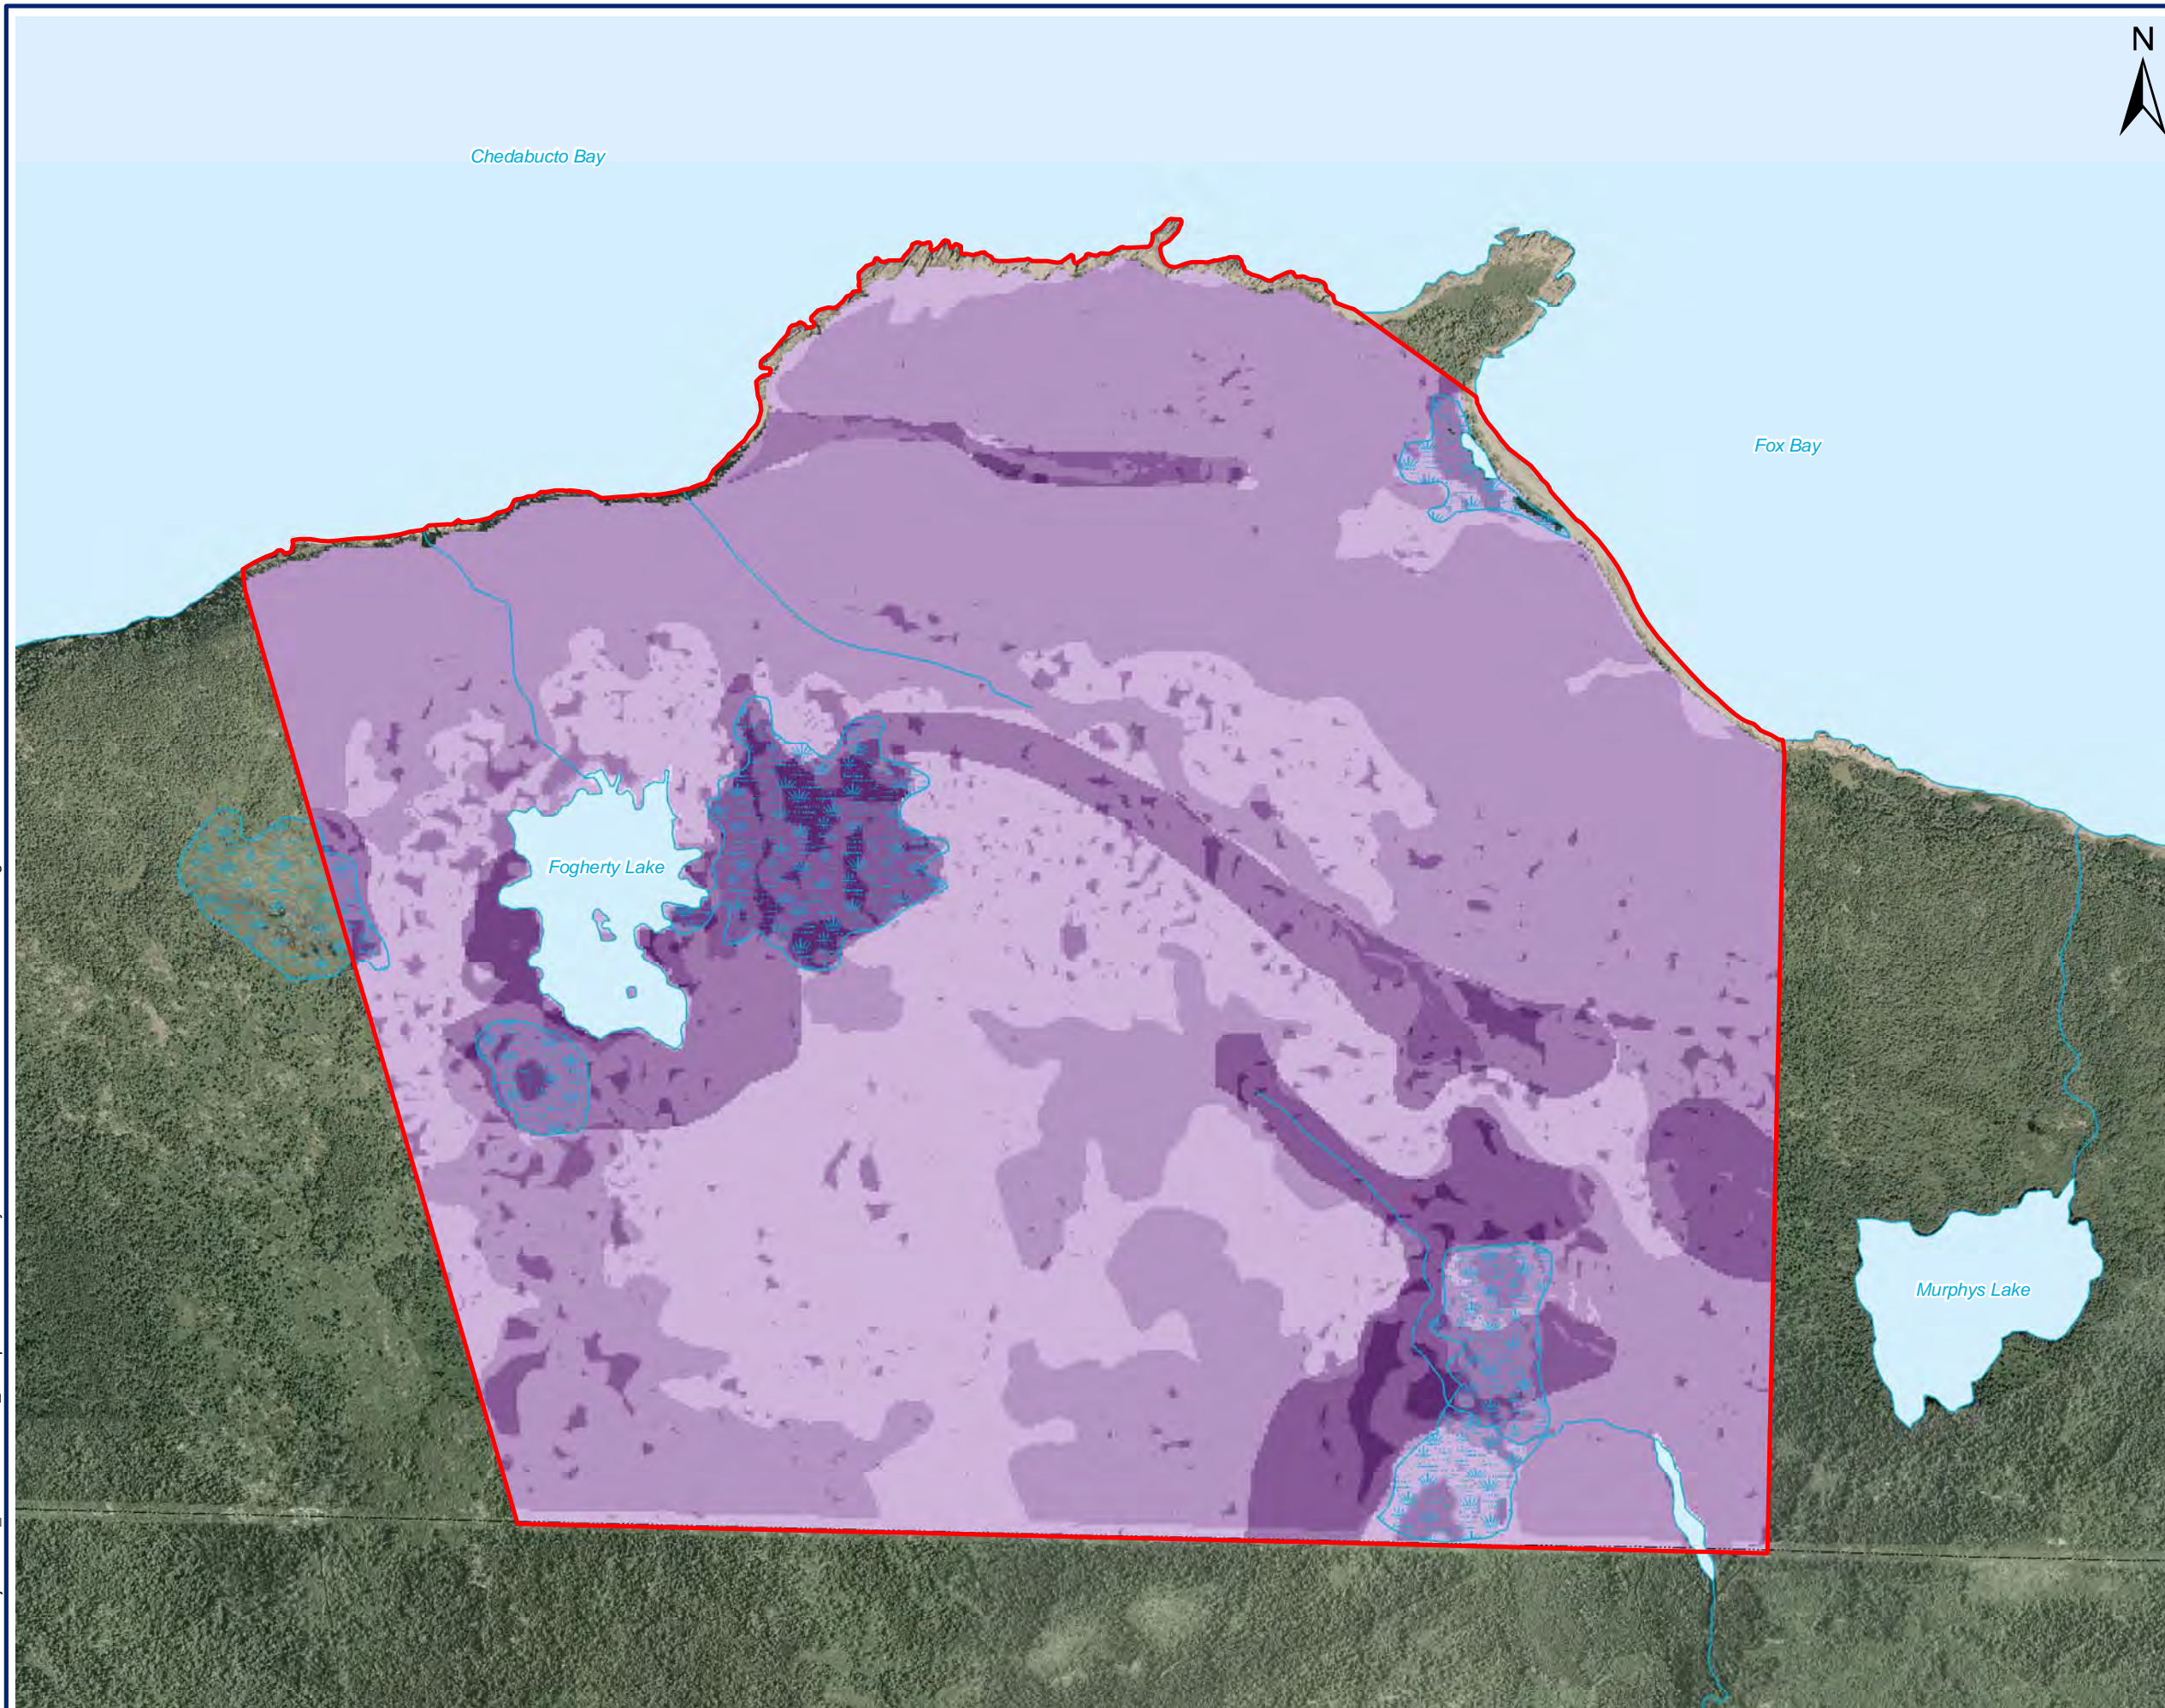
- LEGEND**
- Property Boundary
  - Waterbody
  - Wetland
  - Watercourse
  - Utility Line
- Estimated Average Annual Recharge (mm/y)
- <=200 mm/y
  - 200 - 300 mm/y
  - 300 - 400 mm/y
  - 400 - 500 mm/y
  - 500 - 600 mm/y
  - 600 - 700 mm/y
  - >700 mm/y

Drawing 12 was prepared by partitioning the average annual water surplus based on soils/bedrock, topography and ground cover, in a GIS platform. It shows that recharge is typically less than 200 mm in the topographic high areas that exhibit exposed bedrock. Values of 200 to 300 mm are found in the areas of moderate overburden and less steep slopes. In the flatter areas, where the overburden is thickest, typically in the low lying areas, the recharge rates exceed 300 mm/yr and can locally approach 700 mm/yr. (The average annual surplus is 877 mm/yr, and this implies that only 177 mm will runoff in those areas.) Notwithstanding this wide variance across the site, the average annual recharge for the entire site is 351 mm/yr, as stated above.

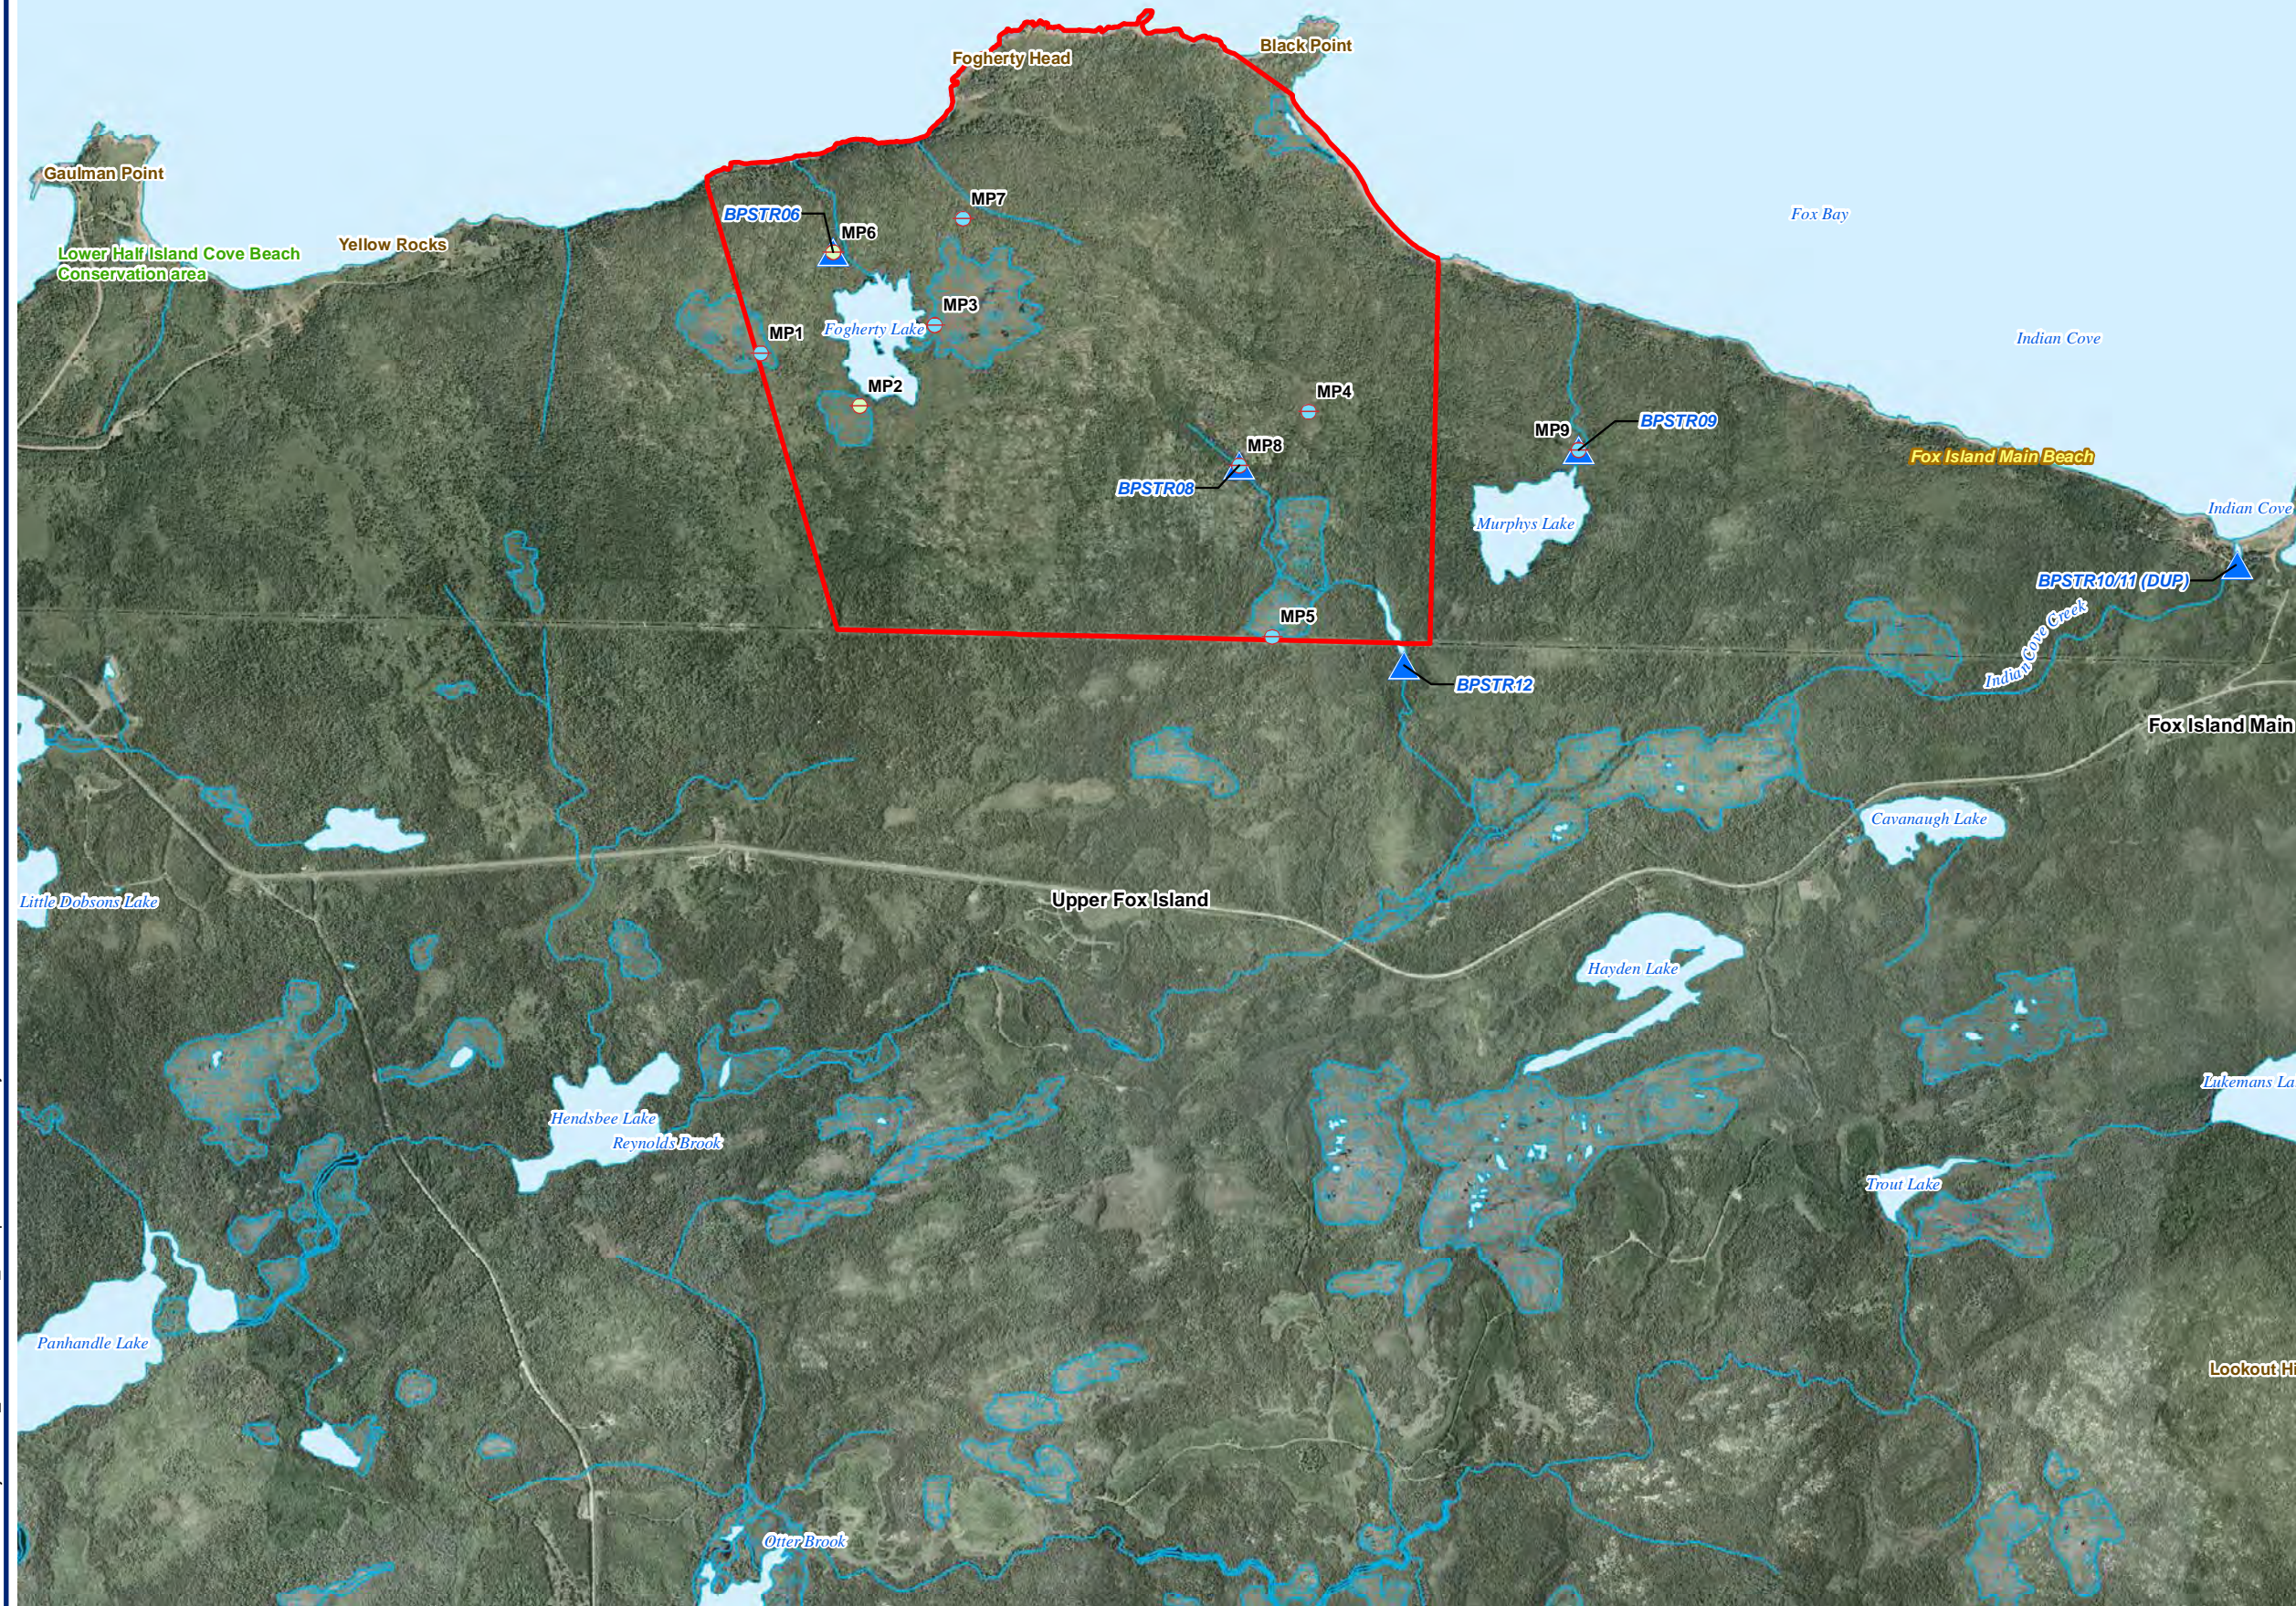
Figure 1 Residential Wells

**Figure 1** identifies the locations of the residential wells and **Table 1** summarizes the information collected from the questionnaires.

As shown on **Figure 1**, the area west of the Site along Half Island Cove Road utilizes dug wells for potable water. In July, water levels were within 3.0 m of the ground surface and no concerns of water quantity or quality were expressed. Two residents (BPRW003 and BPRW004) reported that springs emerge from the hill to the south of Half Island Cove Road.

Boreholes locations are shown on **Figure 1**.

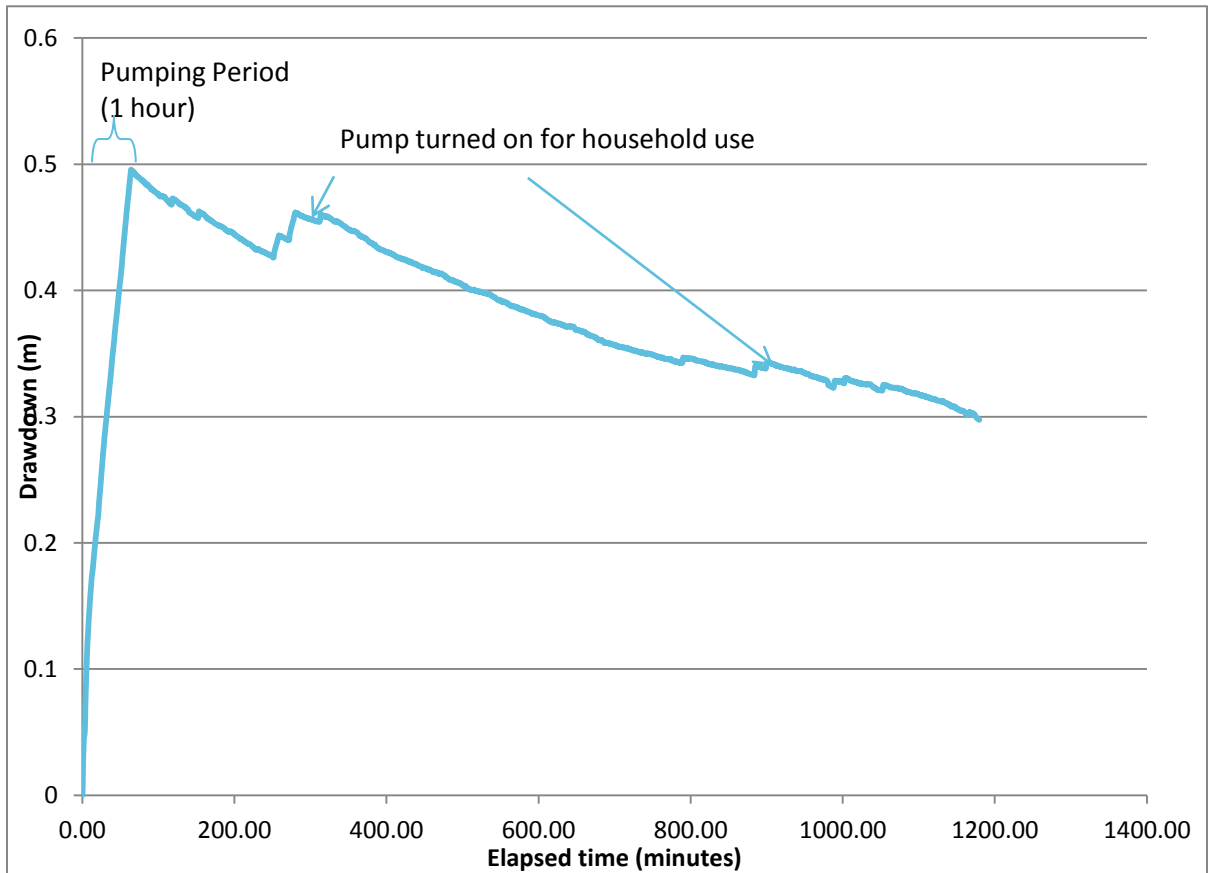
**Figure 3: BPRWA001 Yield Test Observations**

The data recorded during the test is presented in **Figure 3**. The maximum drawdown was 0.495 m. Recovery of 0.198 m of recovery was observed over a period of 1,110 minutes (18.5 hours). The data were analyzed using the Theis equation in Aqtesolv software and the results are presented in **Appendix B**. The curve was matched to the late recovery period. The drawdown data have considerable uncertainty because the true pumping rate in the well is not known and the pump may have been turned off and on intermittently during the pumping portion of the test as governed by the pressure tank. The initial recovery data appear to be influenced by the pump coming on from household use. The time of day corresponding to early recovery data is the early evening when household water use is expected. The portion of the data used to match the Theis curve corresponds to the overnight period when water usage is expected to be minimal. The estimated transmissivity of the unconsolidated surficial deposits that provide water to the well is  $2.5 \times 10^{-6}$  m<sup>2</sup>/sec, corresponding to a hydraulic conductivity of  $8 \times 10^{-7}$  m/sec. These values are consistent with glacial till deposits in Nova Scotia and appear to represent a reasonable order of magnitude approximation.

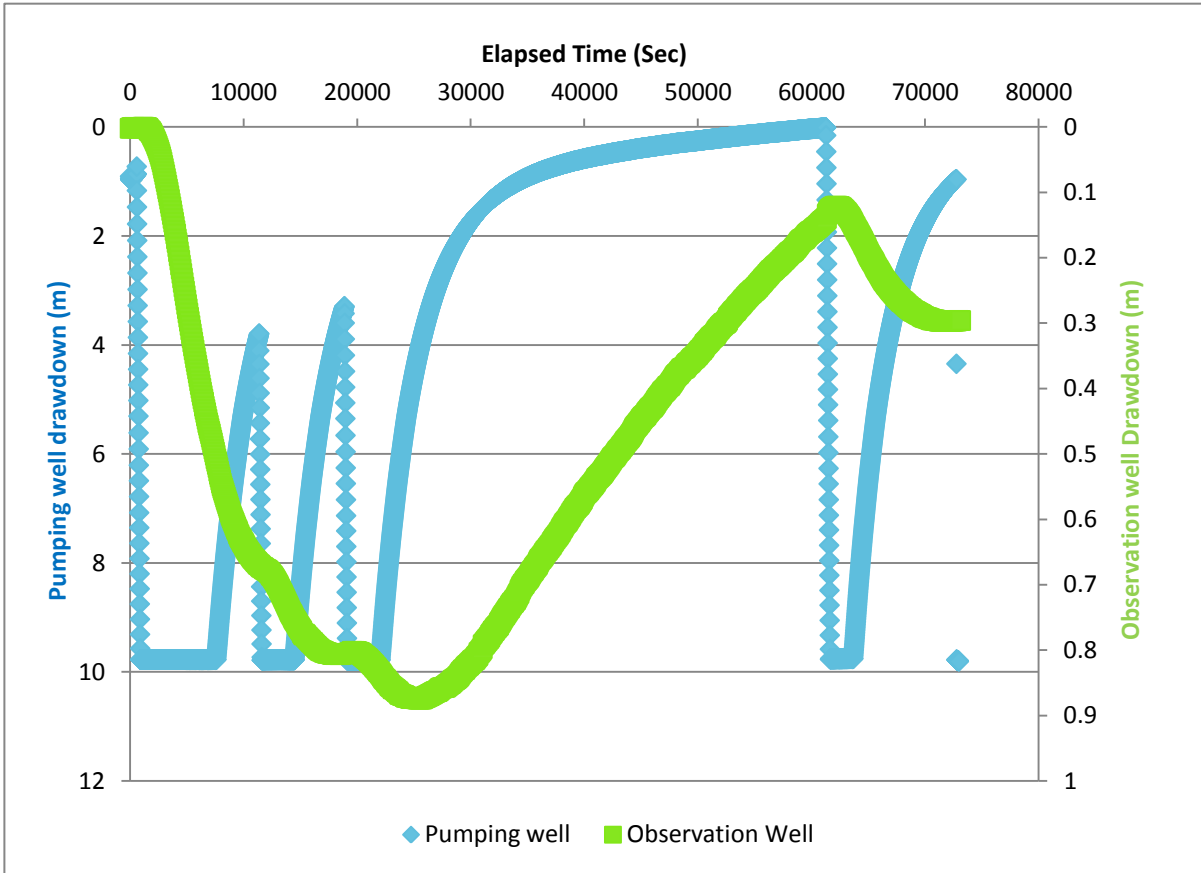
**Figure 4: BPRWA007 Yield Test observations**

A data logger (10 m depth range) was installed in the observation well at a depth of ~5 m below the water level and a second data logger (10 m depth range) was installed in the pumping well at a depth of ~9 m below the water level. The water supply system consists of a submersible pump in the well that transfers water to a holding tank. Water supply to the cottages/residence is drawn from the holding tank and when the holding tank water level is drawn down to a particular level, the pump in the well is turned on. Therefore, during the yield test, the pump was turned on several times. The data logger information from the yield test is presented in **Figure 4**.
