**Appendix A – Hydrogeological Technical Study**

**Proposed Black Point Quarry Project  
Guysborough County, Nova Scotia**

**Hydrogeological Technical Report**

**February 2015  
SLR Project No.: 210.05913.00000**

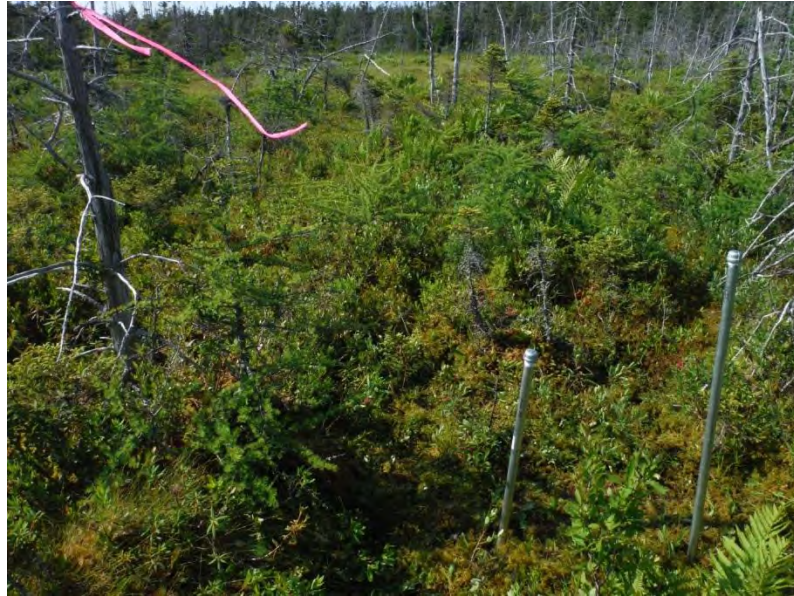
**Photo 1: MP4**

MP4 is located in a small wetland area in the eastern portion of the property. Topography indicates the wetland drains to Murphys Lake. The wetland was wetter than those hosting the MPs installed near Fogherty Lake. Outcrops of bedrock are visible within 50.0 m of MP4. Bedrock was encountered at a depth of ~ 3 m.

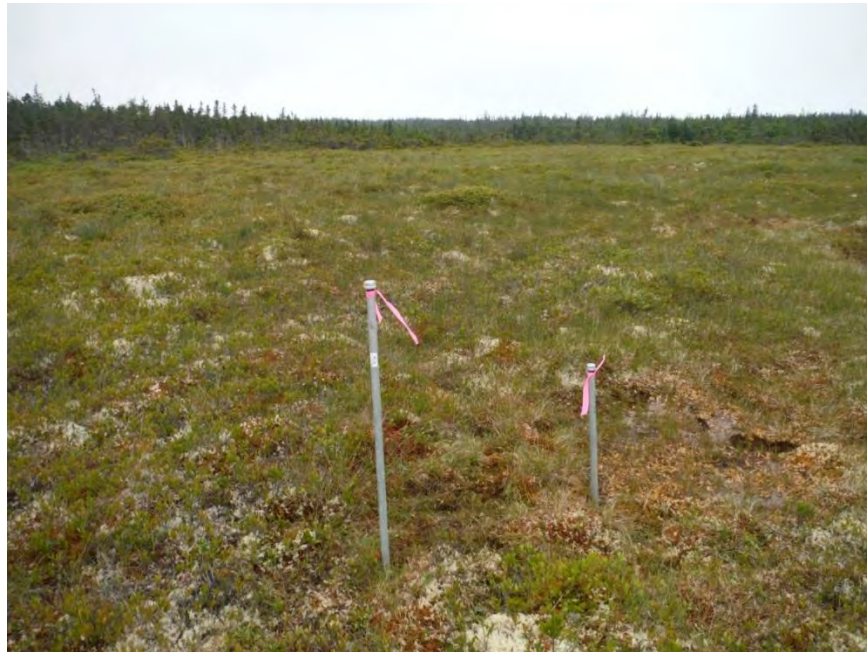
**Photo 2: MP5**

MP5 is located in a large wetland area at the southern end of the property. The wetland feeds a stream discharging to the south (BPSTR012 stream monitoring location). Thick sphagnum moss and peat is found to a depth >1.5 m. Bedrock depth is variable from 1.5 m to 3.5 m.

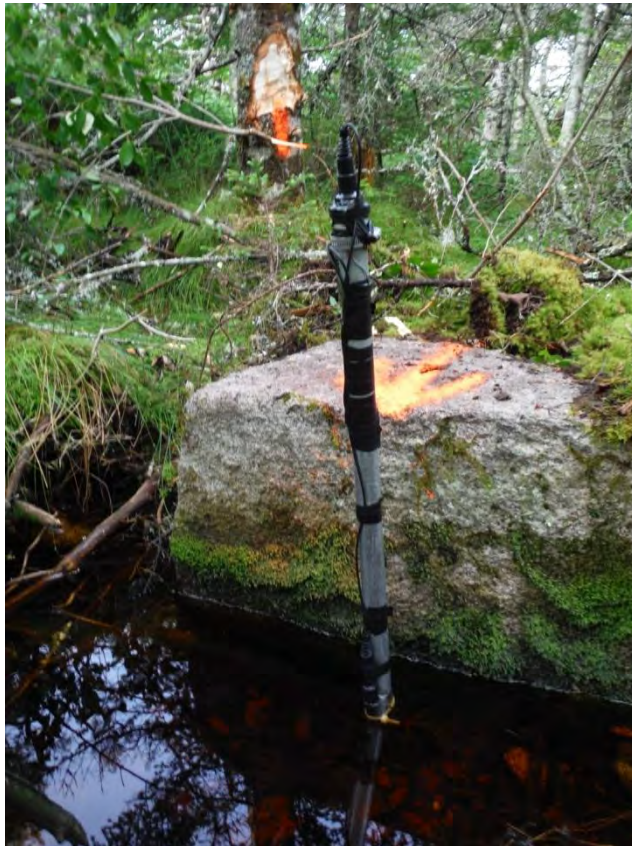
**Photo 3: MP6 with Data Logger**

MP6 is a single 1 inch piezometer installed in the stream discharging from Fogherty Lake. The stream bed has sand, gravel, cobbles and boulders. Piezometer refusal was common at a depth of 0.5 m. Stream flow measurement, surface water sampling and field parameters measurements were completed at MP6. The piezometer is instrumented with a data logger.

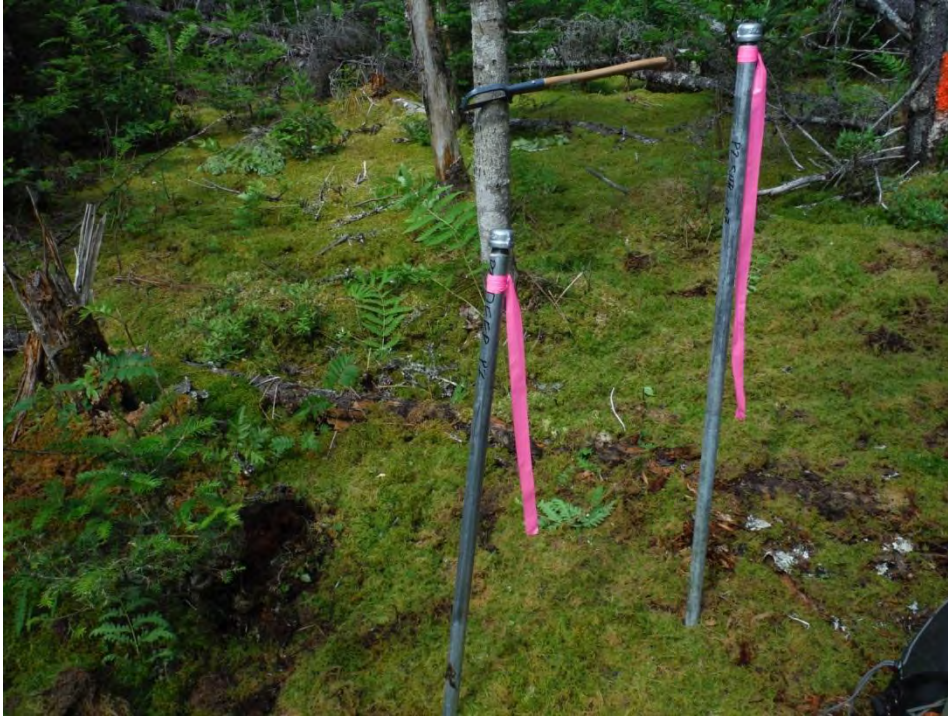
**Photo 4: MP7**

MP7 is located in a northwest trending lineament with ~ 10 m of relief, which is 5 to 10 m wide. No water was running at the location and there is no indication of a stream bed. A nested set of MPs were installed. Moss is found to a depth of 0.5 m, followed by sediment/till. Bedrock/piezometer refusal was not encountered, but piezometer insertion was increasingly difficult past the first pipe length.

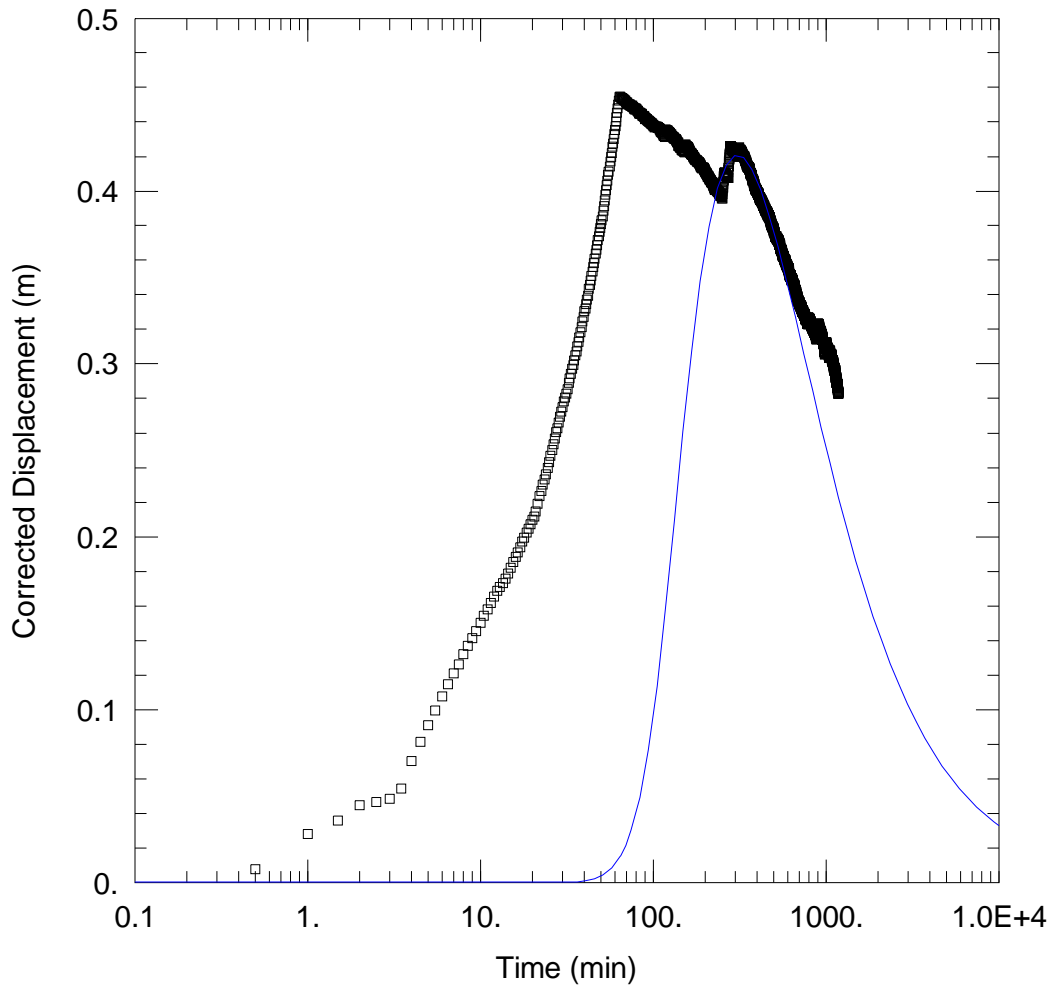
### WELL TEST ANALYSIS

Kz/Kr = 1.0E-5

b = 3. m

The data recorded during the test is presented in **Figure 3**. The maximum drawdown was 0.495 m. Recovery of 0.198 m of recovery was observed over a period of 1,110 minutes (18.5 hours). The data were analyzed using the Theis equation in Aqtesolv software and the results are presented in **Appendix B**. The curve was matched to the late recovery period. The drawdown data have considerable uncertainty because the true pumping rate in the well is not known and the pump may have been turned off and on intermittently during the pumping portion of the test as governed by the pressure tank. The initial recovery data appear to be influenced by the pump coming on from household use. The time of day corresponding to early recovery data is the early evening when household water use is expected. The portion of the data used to match the Theis curve corresponds to the overnight period when water usage is expected to be minimal. The estimated transmissivity of the unconsolidated surficial deposits that provide water to the well is  $2.5 \times 10^{-6}$  m<sup>2</sup>/sec, corresponding to a hydraulic conductivity of  $8 \times 10^{-7}$  m/sec. These values are consistent with glacial till deposits in Nova Scotia and appear to represent a reasonable order of magnitude approximation.

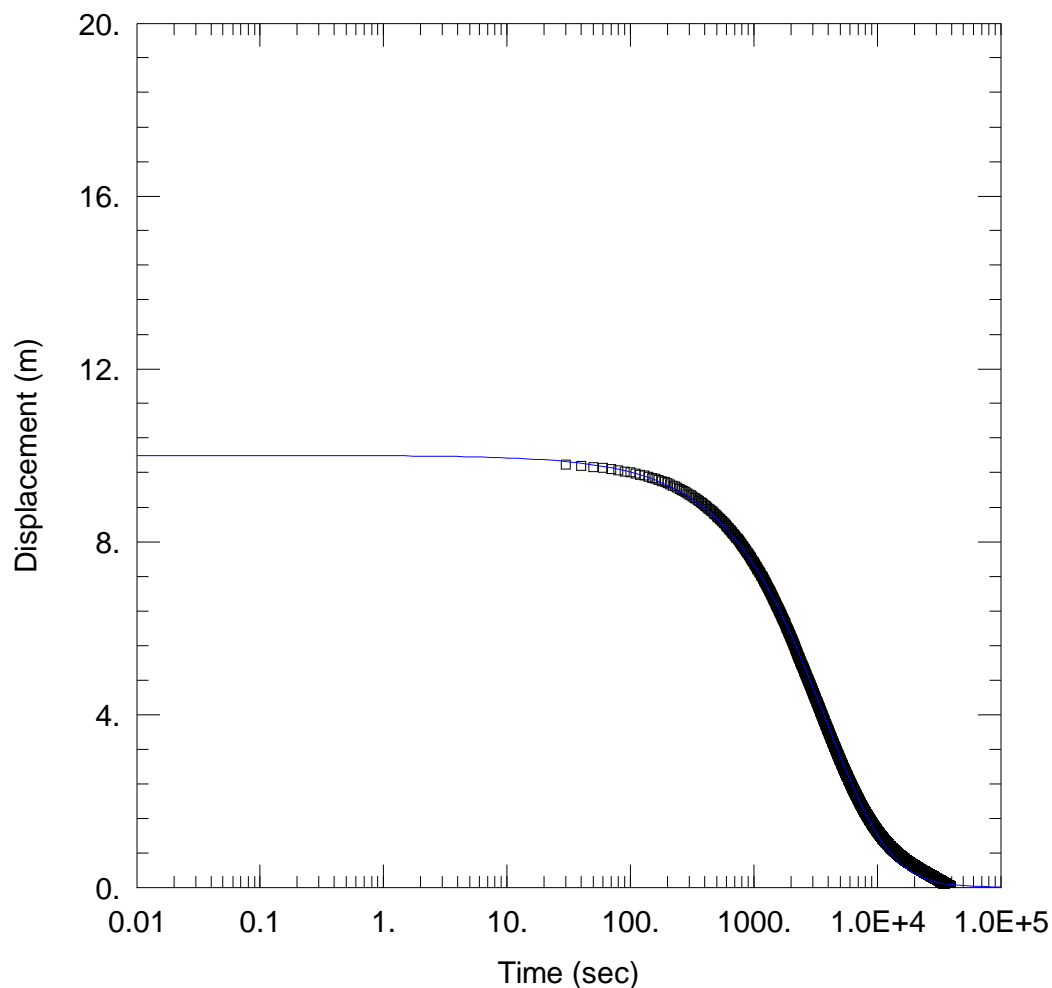
Aquifer Model: <u>Unconfined</u>	Solution Method: <u>KGS Model</u>
Kr = <u>5.807E-8 m/sec</u>	Ss = <u>1.402E-6 m<sup>-1</sup></u>
Kz/Kr = <u>1.</u>

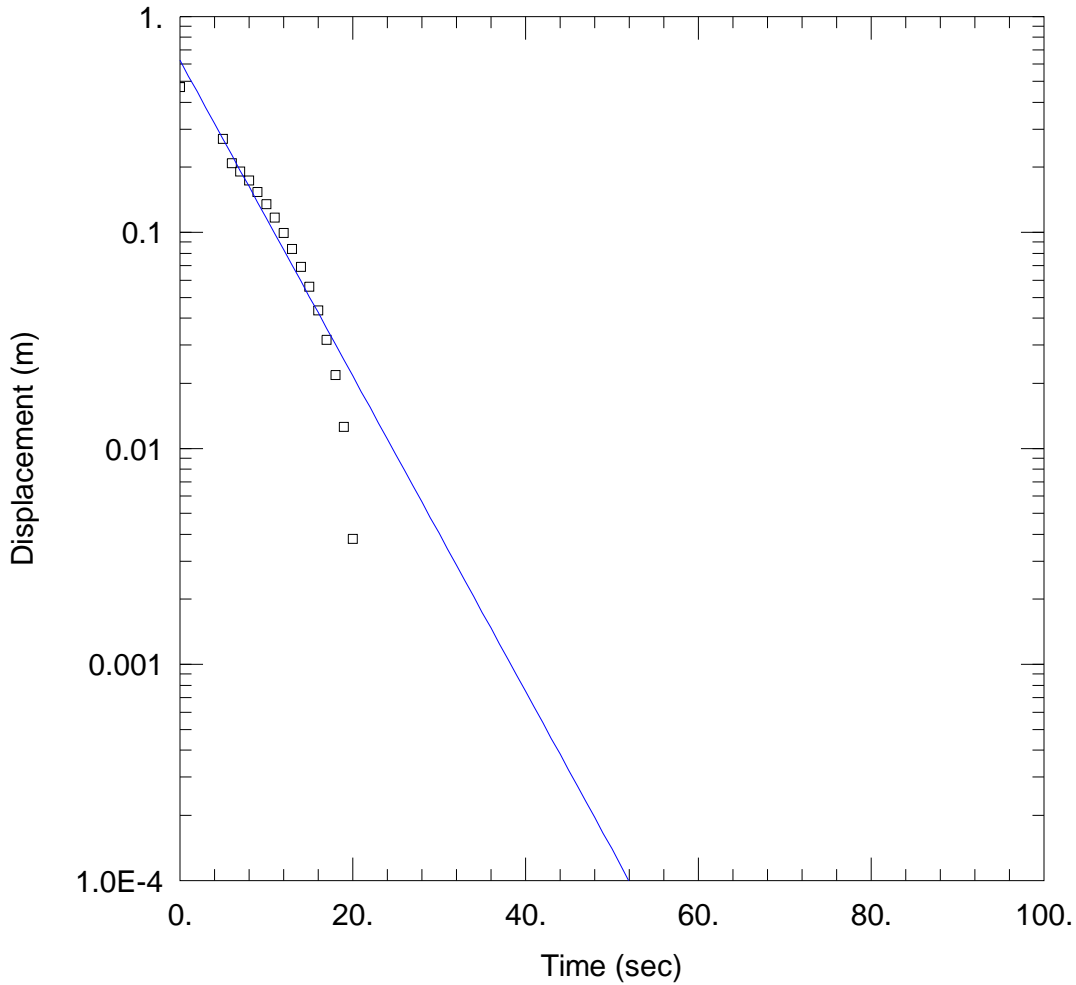
Aquifer Model: Unconfined                      Solution Method: Bouwer-Rice  
 $K = 2.343E-6$  m/sec                       $y_0 = 0.1435$  m

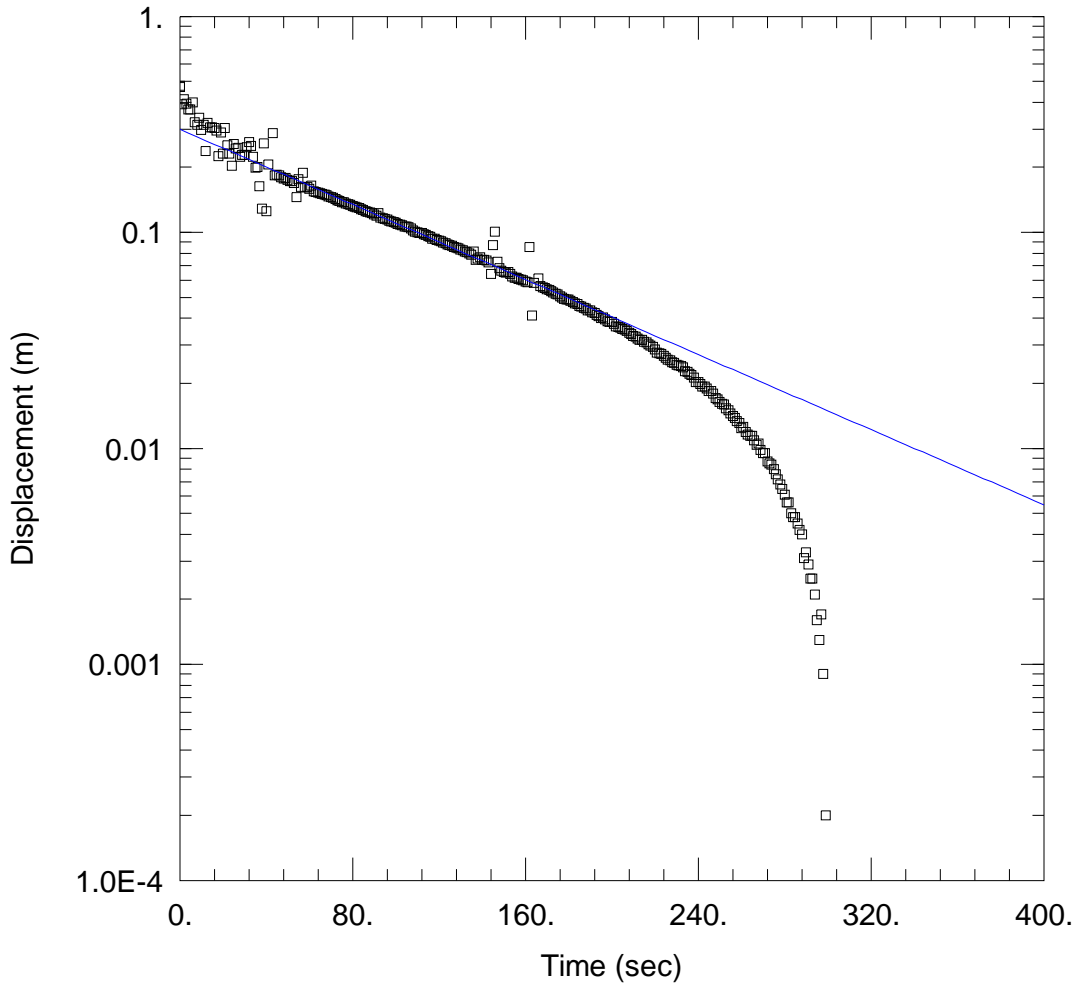
Aquifer Model: Unconfined                      Solution Method: Bouwer-Rice  
 K = 1.412E-5 m/sec                      y0 = 0.6262 m

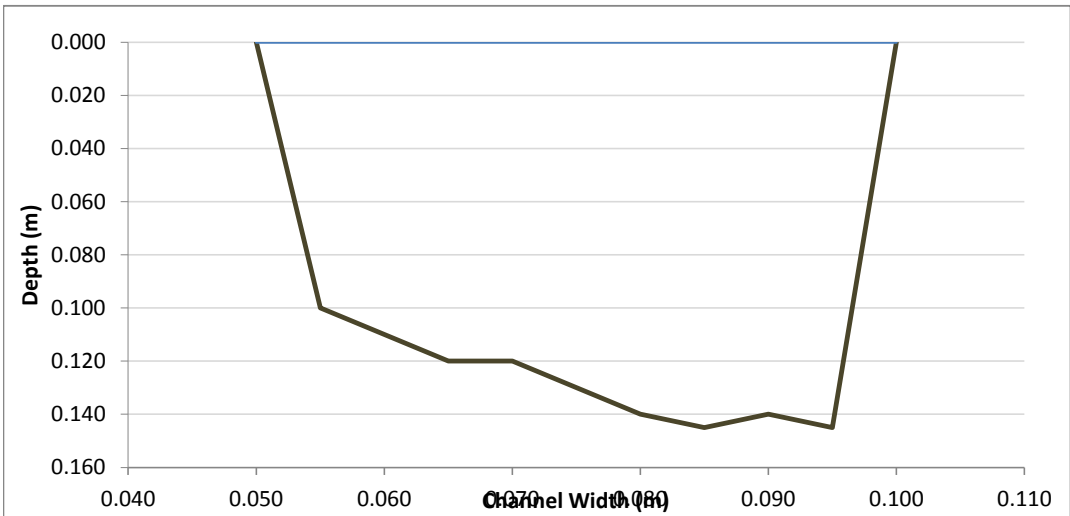
Station (m)	Depth (m)	Area (m <sup>2</sup> )	Velocity (m/s)	Q (m <sup>3</sup> /s)	Notes
0.050	0.000	0.0000000	0.00	0.00000000	LB (Looking Upstream)
0.055	0.100	0.0005000	-0.01	-0.00000500	
0.060	0.110	0.0005500	0.00	0.00000000	
0.065	0.120	0.0006000	0.00	0.00000000	
0.070	0.120	0.0006000	0.00	0.00000000	
0.075	0.130	0.0006500	0.00	0.00000000	
0.080	0.140	0.0007000	0.01	0.00000700	
0.085	0.145	0.0007250	0.01	0.00000725	
0.090	0.140	0.0007000	0.01	0.00000700	
0.095	0.145	0.0007250	0.02	0.00001450	
0.100	0.000	0.0000000	0.00	0.00000000	RB (Looking Upstream)

**Total**      0.000031    m<sup>3</sup>/s  
                   0.031            L/s

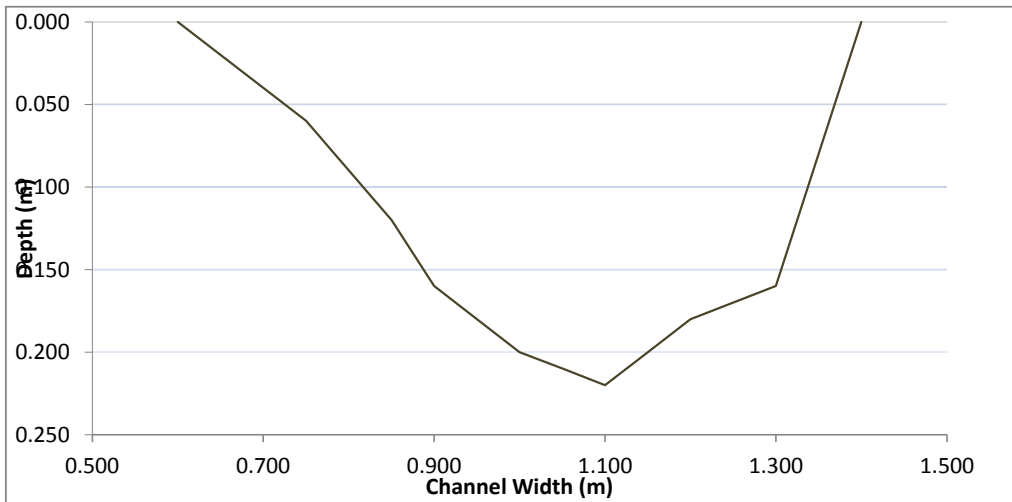
Station (m)	Depth (m)	Area (m <sup>2</sup> )	Velocity (m/s)	Q (m <sup>3</sup> /s)	Notes
0.600	0.000	0.0000000	0.00	0.00000000	LB (Looking Upstream)
0.750	0.060	0.0075000	-0.02	-0.00015000	
0.850	0.120	0.0090000	0.00	0.00000000	
0.900	0.160	0.0080000	0.01	0.00008000	
0.950	0.180	0.0090000	0.01	0.00009000	
1.000	0.200	0.0100000	0.01	0.00010000	
1.050	0.210	0.0105000	0.00	0.00000000	
1.100	0.220	0.0110000	0.01	0.00011000	
1.150	0.200	0.0100000	0.01	0.00010000	
1.200	0.180	0.0135000	0.00	0.00000000	
1.300	0.160	0.0160000	-0.01	-0.00016000	RB (Looking Upstream)
1.400	0.000	0.0000000	0.00	0.00000000

Total      0.000170      m<sup>3</sup>/s  
    L/s  
    0.170

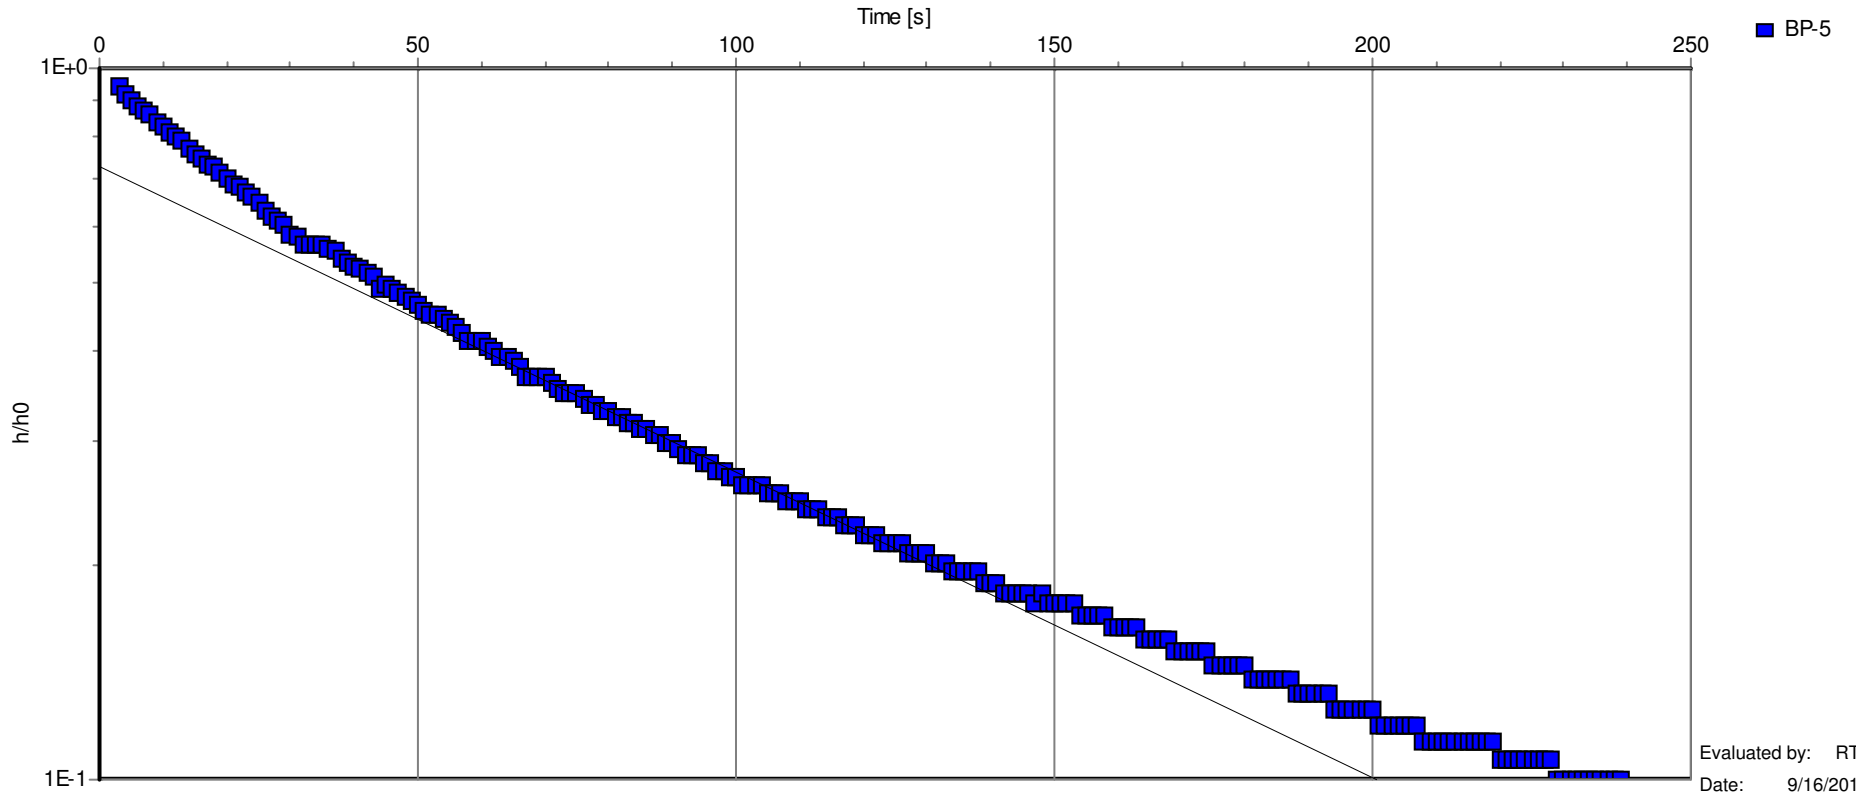
BP-5 Slug Test [Bouwer & Rice]

Saturated screen length = 86.7 [m] Max. Head Change = 0.47 [m]  
R (eff) not used in analysis

Conductivity: 6.06E-7 [m/s]

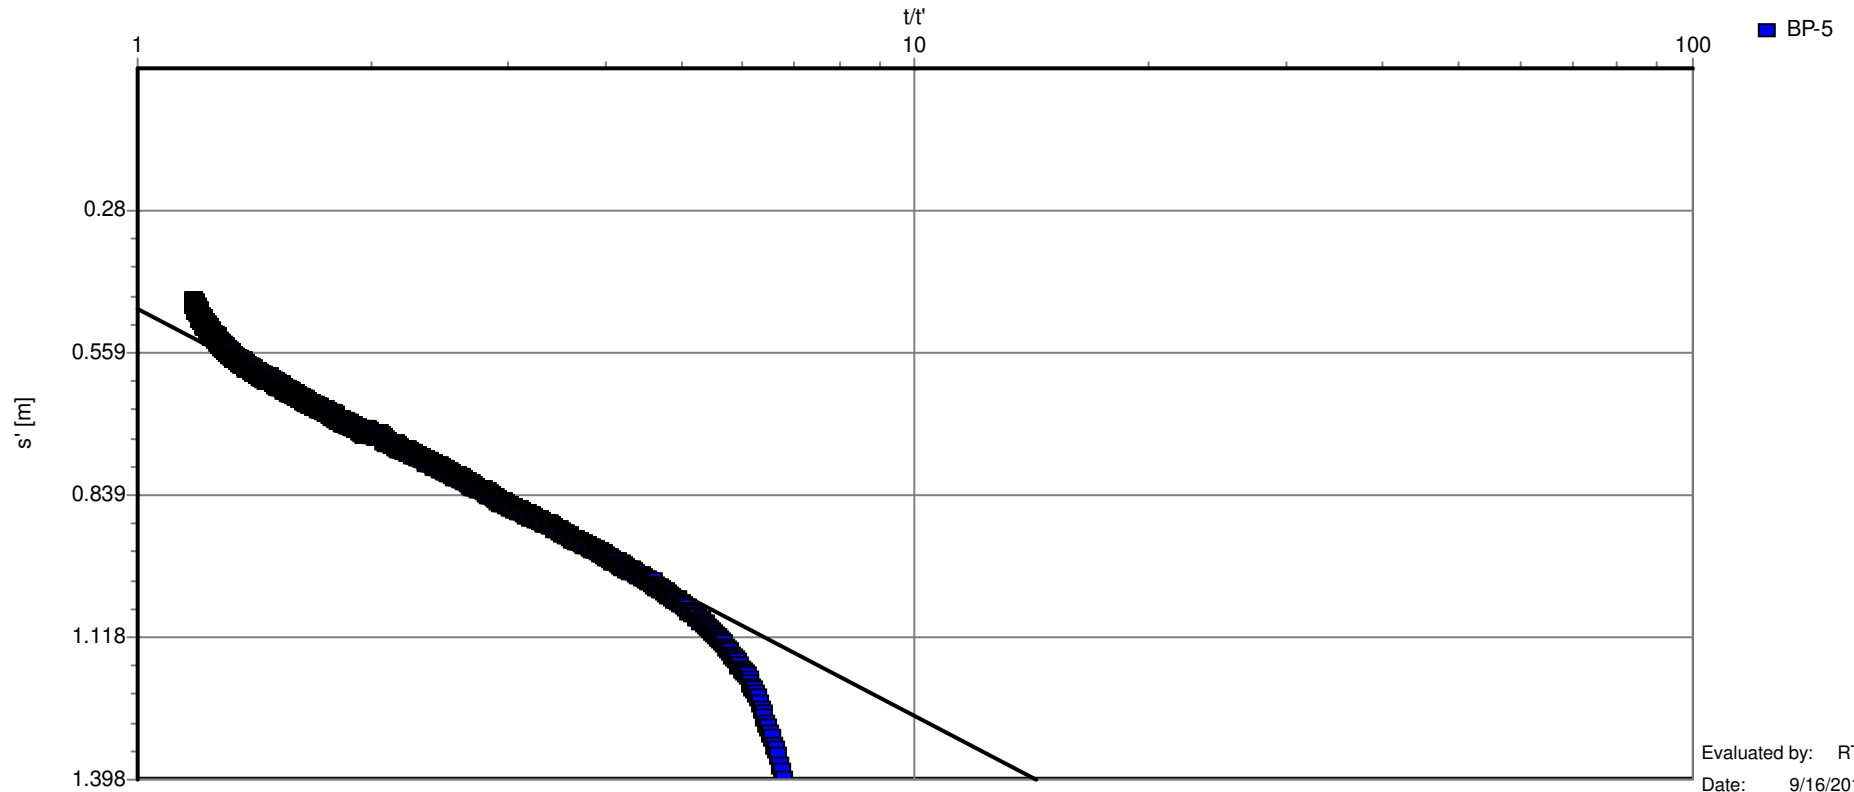
BP-5 Recovery Test [Theis Recovery]

Analysis results: Transmissivity: 2.29E-5 [m<sup>2</sup>/s] Conductivity: 2.68E-7 [m/s]

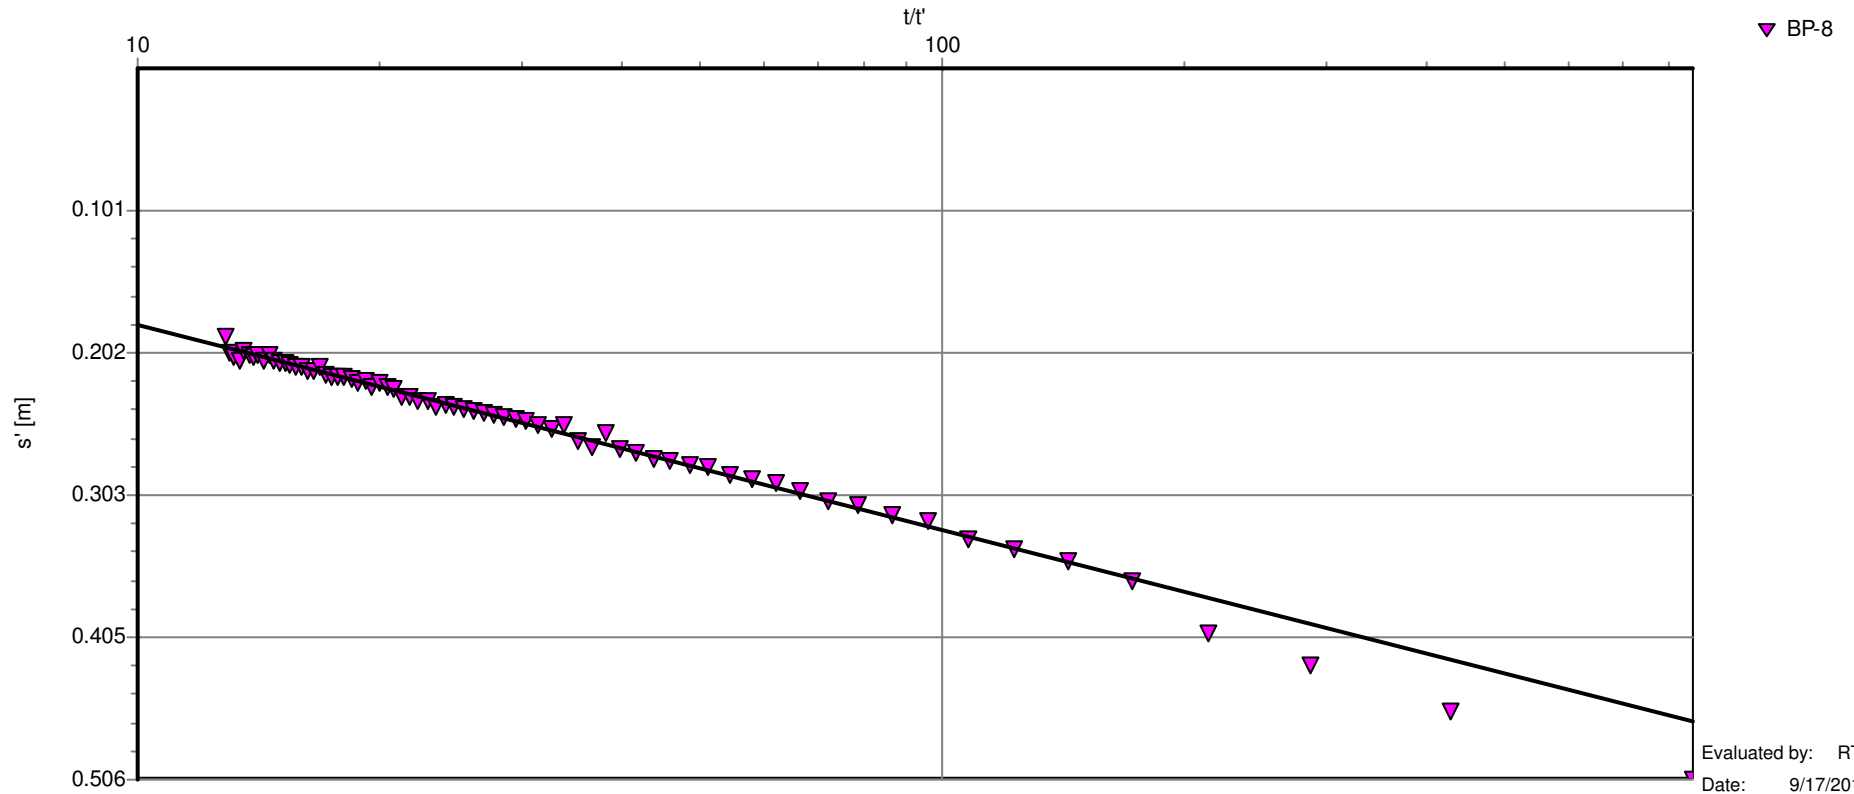
BP-8 Recovery Test [Theis Recovery]

Analysis results: Transmissivity: 6.67E-5 [m<sup>2</sup>/s] Conductivity: 6.47E-7 [m/s]

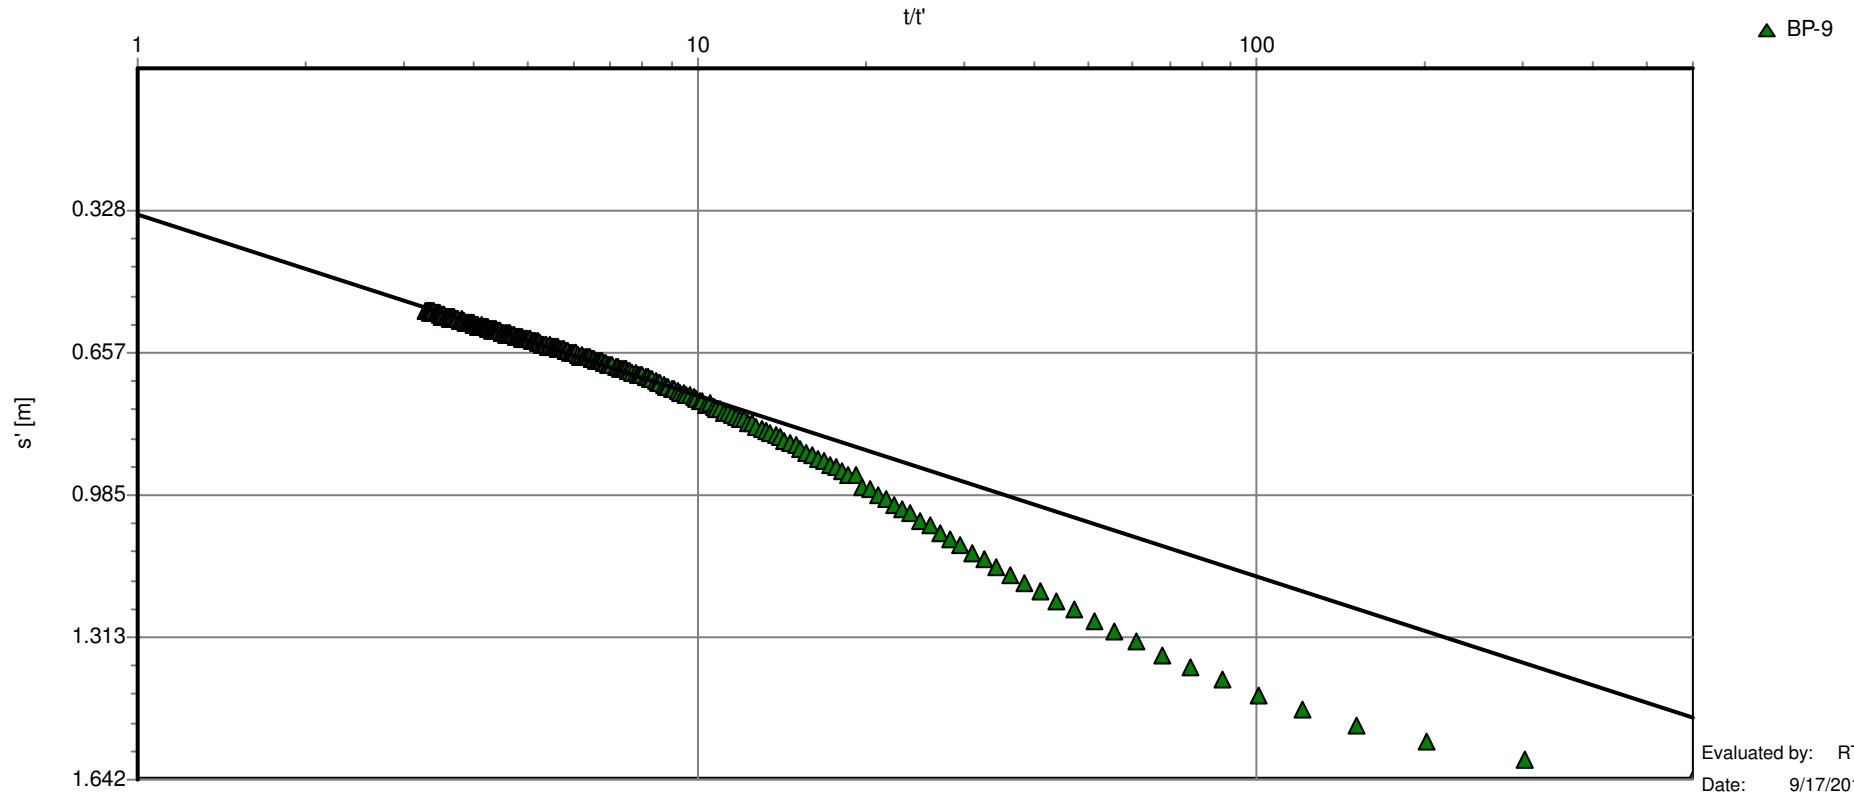
BP-9 Recovery Test [Theis Recovery]

Analysis results: Transmissivity: 1.90E-5 [m<sup>2</sup>/s] Conductivity: 1.53E-7 [m/s]

Test parameters: Pumping Well: BP-9 Pumping Time: 6010 [s]  
 Screen radius: 0.03785 [m] Aquifer thickness: 124.11  
 Screen length: 130 [m] Boring radius: 0.03785 [m]  
 Discharge Rate: 4.333E-5 [m<sup>3</sup>/s]

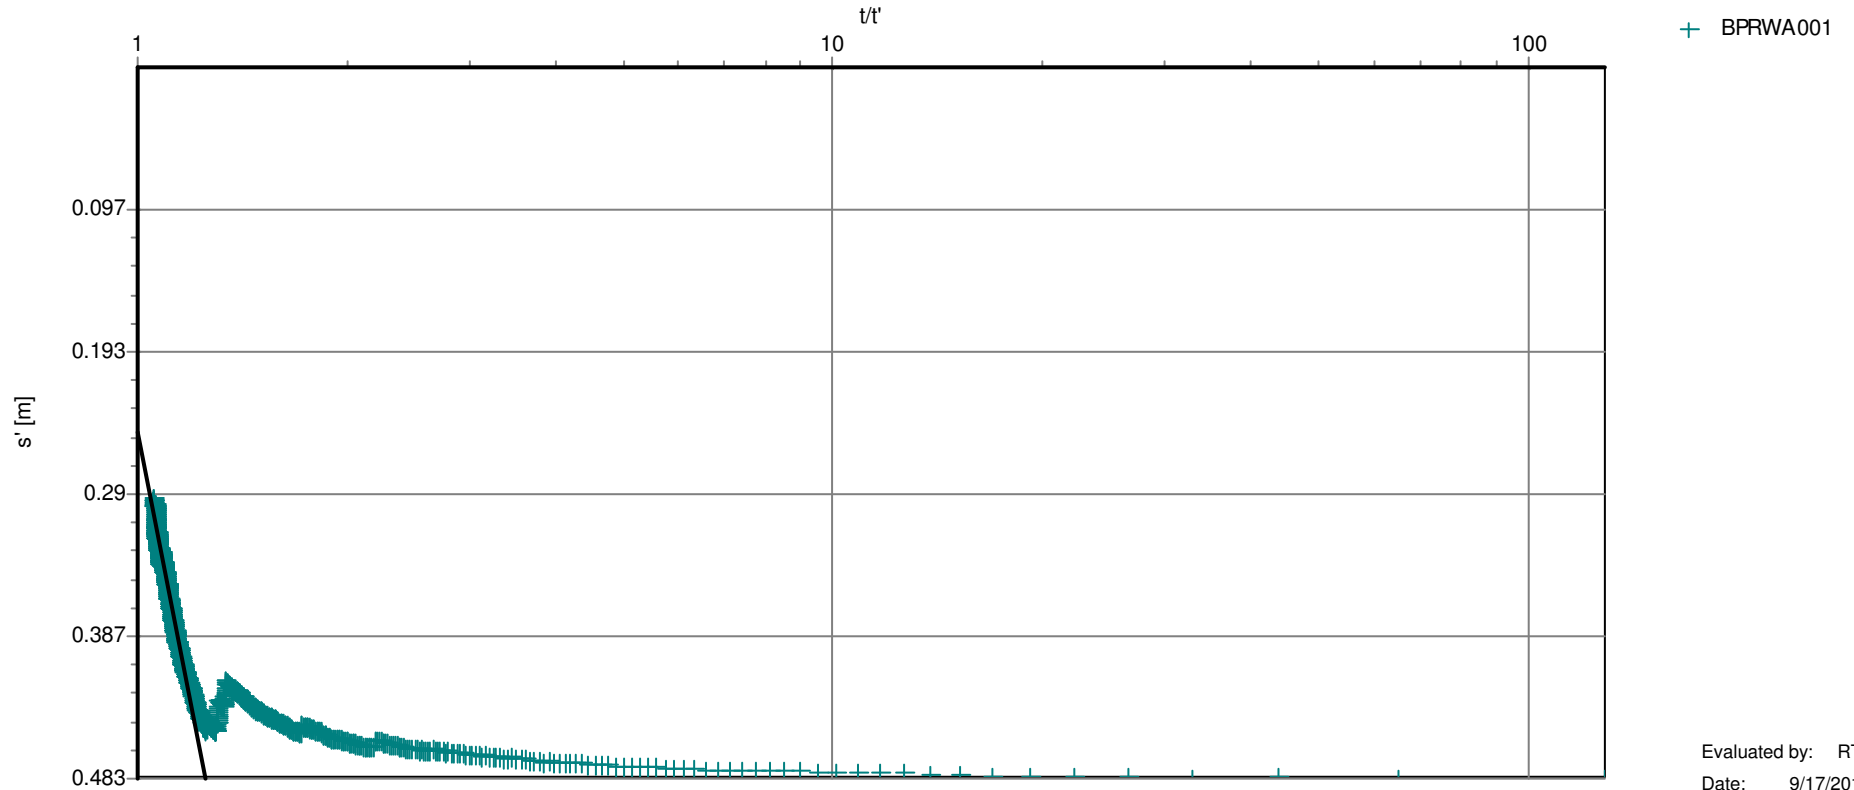
BPRWA001 [Theis Recovery]

Analysis results: Transmissivity: 2.15E-5 [m<sup>2</sup>/s] Conductivity: 2.15E-6 [m/s]

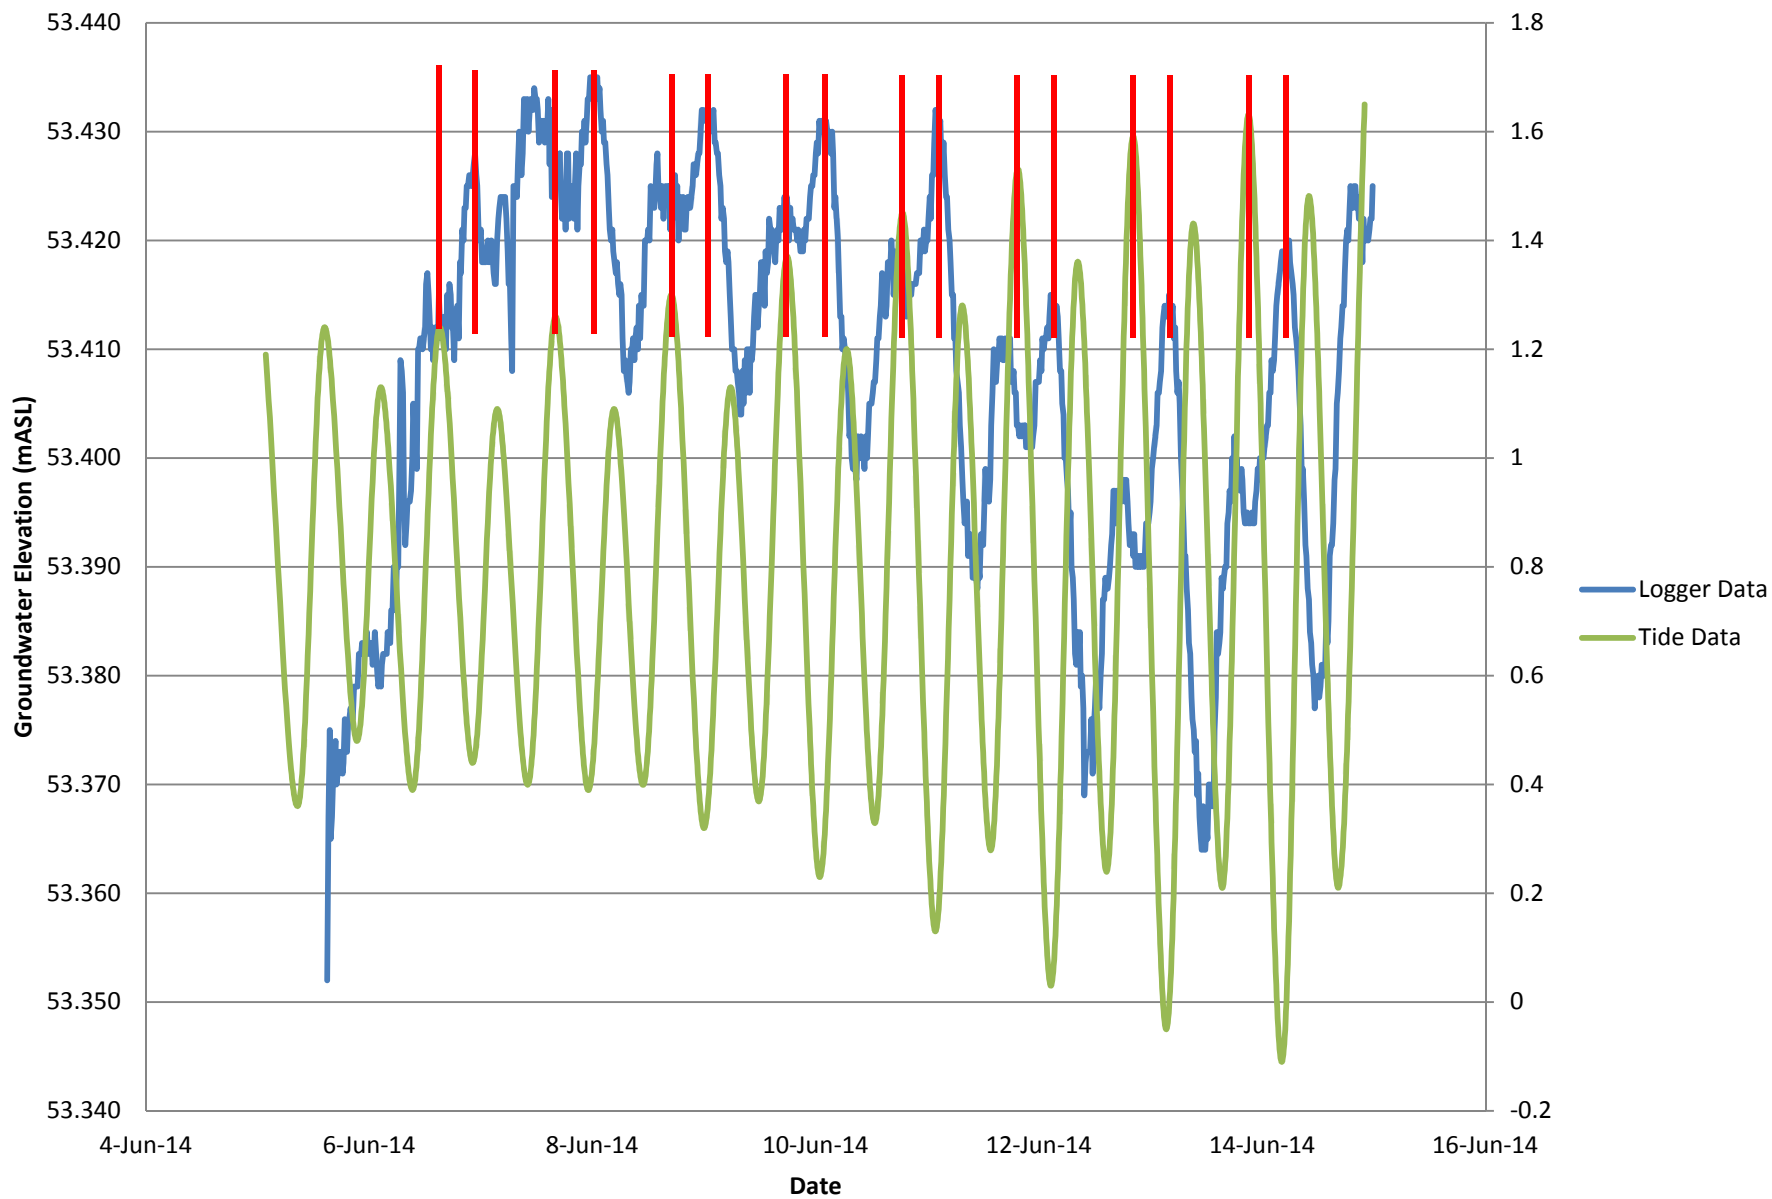
# BP8 Groundwater Elevation vs Tidal Fluctuation at Guysborough

- a small tidal influence in the order of 10 to 30 mm is seen in the granite boreholes as illustrated by the comparison of the daily high tide with the daily high groundwater level in Attachment H. The apparent lag between the daily high tide and the corresponding groundwater level high is approximately 8 hours. Given the wide topographical range found on site this small change over several hours on a measurement day does not affect the interpretation of the water table.
